# Abbot Hall Façade and Grounds Inspection & Assessment Report

Town of Marblehead, Massachusetts

June 30, 2017

# Abbot Hall - Exterior Envelope and Ground Assessment

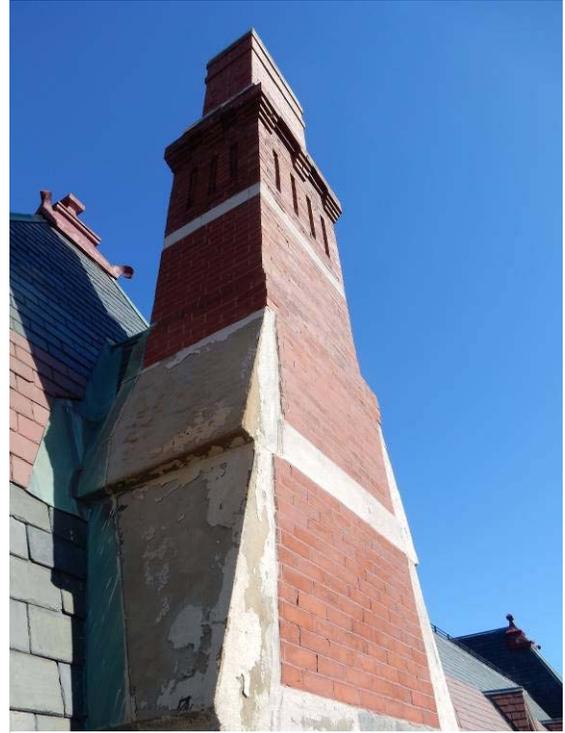
*Existing Chimney*

The chimney located on the southeast corner of the building is severely deteriorated. The original portion of the chimney was constructed with sandstone shingle stones, sandstone bands and decorative brick inlays. The mortar is very weathered and much of the mortar is missing. In the 1970's the chimney had a 10' brick extension installed on top of the original brick chimney. The extension was installed to provide the required height for draft above the adjacent roof. The chimney has two lined flues for the two natural gas boilers. The flue liners were installed in the original brick chimney flues and terminate at the top of the chimney with a metal chimney cap.

The chimney needs to be disassembled down to the gutter line of the roof, and the base Nova Scotia shingle stone should be reset or replaced. When the chimney is rebuilt it needs to meet current seismic code requirements. This will require the chimney to be braced back to the roof. With the current boilers, the chimney will need to be extended to the current 1970's chimney height extension. The flue liners need to be removed and reinstalled when the chimney is disassembled. If the boilers are replaced with modern high efficiency condensing boilers, the chimney could be rebuilt to the original chimney height.

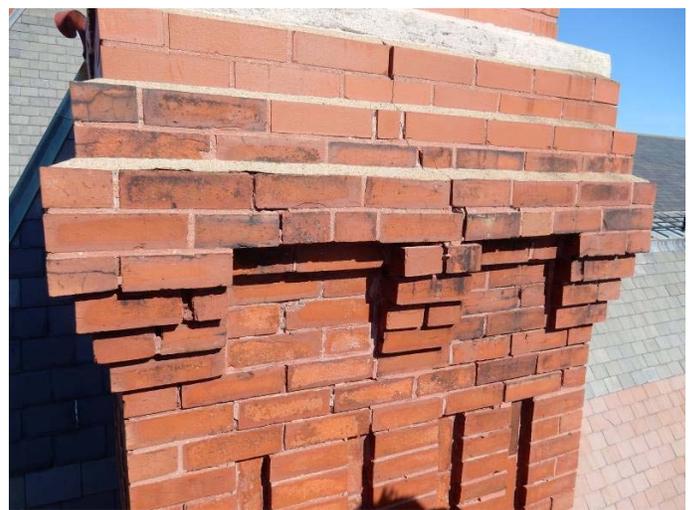
*Deterioration at Original Chimney*

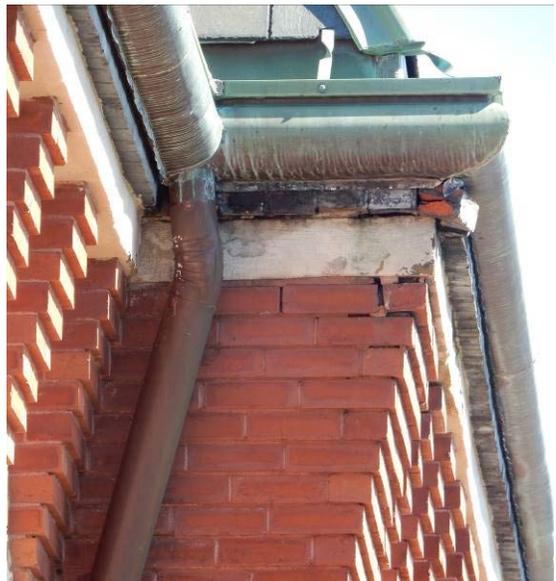
There is a header course of black glazed brick directly below the gutter that supports the gutter. This course of brick is in very poor condition and is not tied into the Nova Scotia Sandstone band below. The brick has no masonry behind it and overhangs the brick cornice below up to 2 ¼". All of the mortar is deteriorated and all of the bricks are loose. At all outside corners the header course is cantilevered at both the head and long face of the brick. At this location the brick is cantilevered 2 ¼" out with a thickness of 3 5/8". These bricks are only held in place by the friction of the gutter above. To repair and stabilize this course of brick the

*Brick under Gutter at Outside Corner*

gutter will need to be removed. Full depth masonry should be installed to lock the brick to the masonry wall.

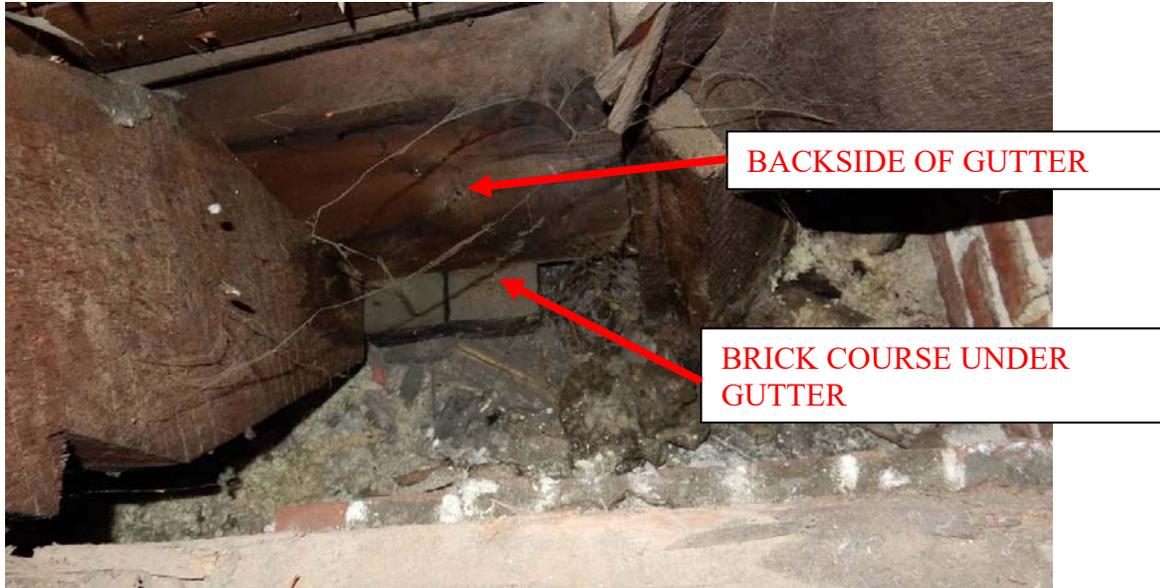
*Loose Brick Course Under Gutter*

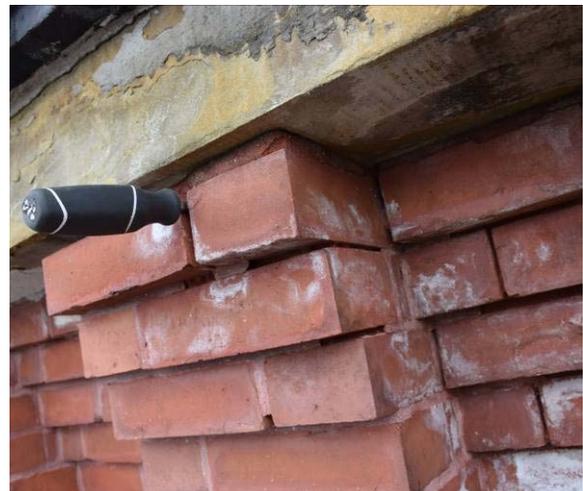
The Sandstone band below the brick header course is supported by a continuous brick cornice. The cornice is composed of 12” wide corbels that are nine brick courses tall. The corbels are exposed on three sides and the deterioration of the mortar is great. All of the mortar has failed and many of the bricks in the corbels are loose. There have been multiple localized repointing campaigns over the years, but all of them were shallow and left deteriorated mortar behind the new pointing mortar. This caused the new mortar to rapidly deteriorate and put a lot of stress on the bricks of the corbels. Many of the brick have cracked, spalled and delaminated. All of the corbels need to have full depth repointing with many of them needed to be rebuilt.

*Open Cornice Joints at Corbel with Loose Brick*

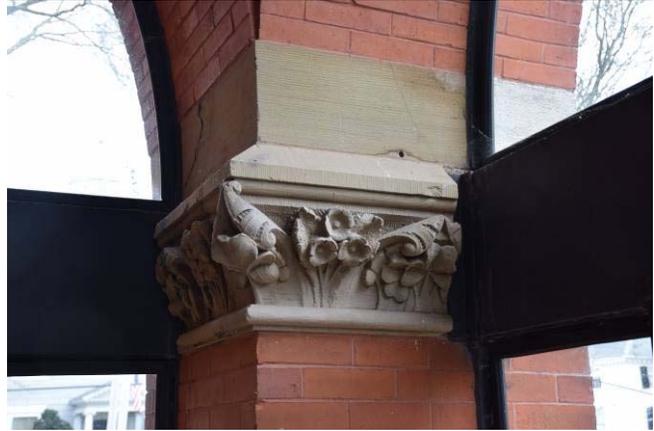
The pinnacle of the gable is missing the original carved Nova Scotia Sandstone finial. At the east portico there are highly decorative bird and grape vine sculpted bands that wrap the pillars of the portico. In the 1970's glass doors and windows were installed to enclose the portico and the sculpture was cut for the installation of the glass. The condition of the sculpture varies significantly depending on the

*Detailed Band Sculpture*

quality of the piece of stone and the orientation of the grain. The sculpture inside the portico was not treated with the white coating and has been protected since the 1970's when glass doors and windows enclosed the portico. The sculpture in the interior has retained much of its detail. All of the sculpture on the exterior has been coated with the white non-breathable coating.

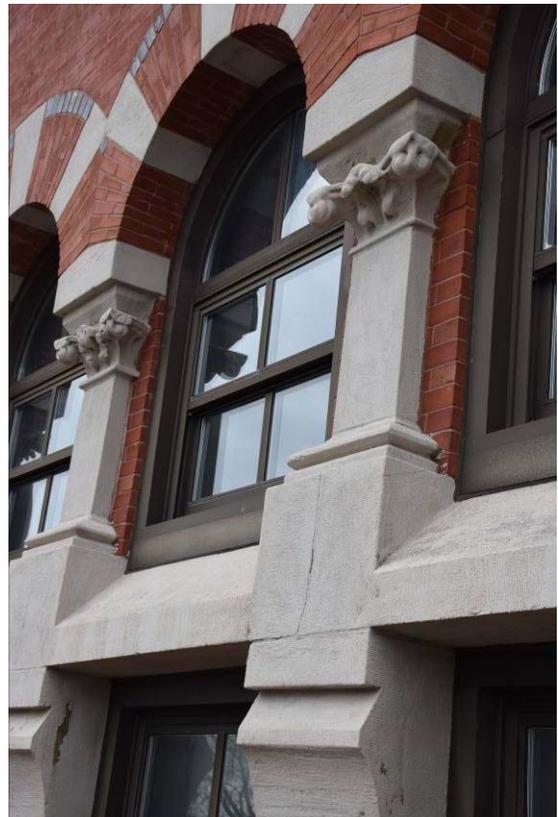
Between the windows above the portico are sculpted column capitals. The capitals sit on rectangular columns and support arched brick window openings. The north side capital is heavily weathered with very little detail remaining. The center capital has retained some detail but has significant weathering. The south side capital has retained most of its detail and is in good condition.

*Column Capitals*

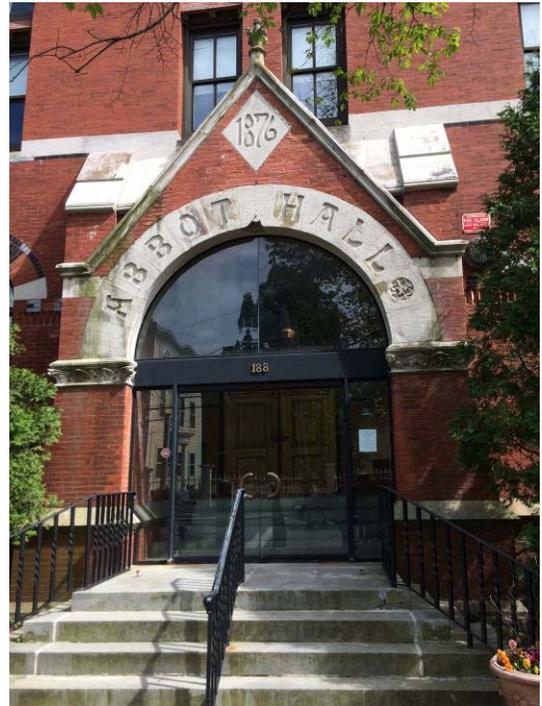
The north entrance to Abbot Hall, designed as the main entrance to the building is located directly off Washington Street, while the east and west entrances are entered from inside the grounds. The projecting portico and gable are entered through a half round opening with a decorative sandstone trim that bears the inscriptions “ABBOT HALL” and “1876”. All of the sandstone at the entrance has been coated with the cementitious coating and needs to be removed. At the peak of the half round opening a corroding ferrous pin caused a softball size piece of sandstone to fall out in the summer of 2016. There are two additional ferrous pins and all of them should be removed. Sloped sandstone shingle stones serve as the roof of the portico topped with a decorative carved finial. The carved finial has weathered but still has retained some of its detailing. The sculpted band stone has retained most of its carved detail and is in good condition. The plantings at the north entry have overgrown the portico and put the entrance in the shade for most of the day. There is biological grown and staining on the majority of the stone and brick at the entrance.

*North Entrance*

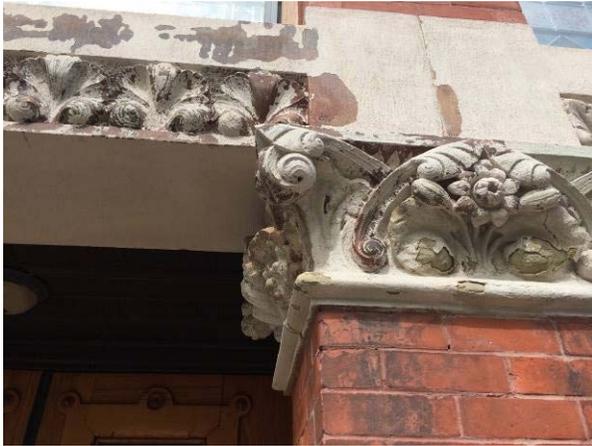
*Column Capital and Header Carvings*

The east entrance has two sets of double wood doors that are separated by a brick column with a carved capital, and a half round stained-glass window that is divided by a granite column with a carved sandstone capital. The half round stained-glass window has a brick and sandstone arch with carved sandstone rosettes at both sides of the base and one at the peak of the arch. Over both door openings entrances is a horizontal carved sandstone header with a detailed floral pattern.

The carved header stones over the entrances are in very good condition. There is the white cementitious coating over all the sandstone that needs to be removed. The capital on the brick column has retained a lot of it's detail but has areas that are flaking and spalling at the underside on the carvings. The granite column between the stained glass is identified on the original drawings as the only granite column on the building. The carved sandstone capital on the granite column has retained most of the carved details but has minor spalling of the elements below the undercut carvings. The rosettes in the arch are in good condition with a high level of detail retention.

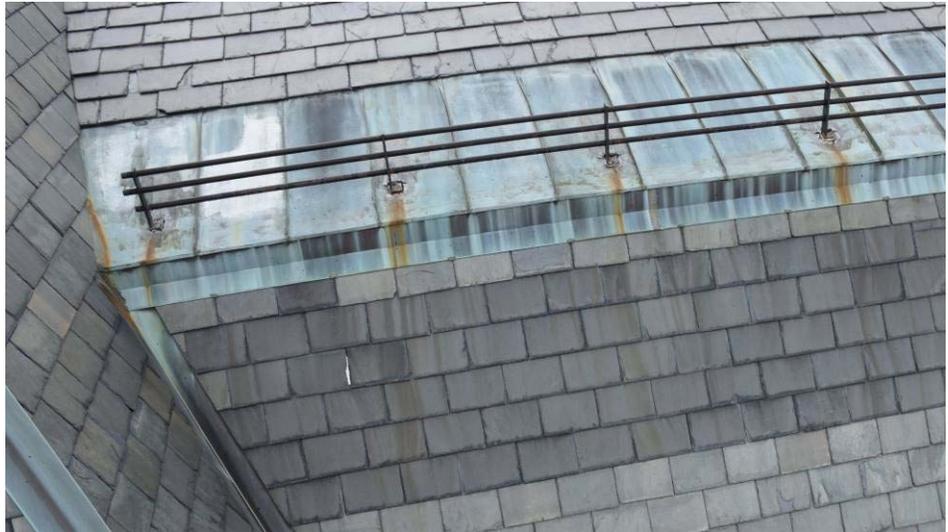
below the gutter. The copper skirt at the bottom of the low sloped roof area has many pin holes and needs to be replaced. The snow rails, which are badly rusting and causing deterioration to the copper skirt, also need to be replaced. The copper flashing at the dormers appear original and in poor condition. The valleys were replaced in 1977 and are in good condition. The ti-coated sheet steel finials at the roof peaks are rusting. The original tin coating has worn off and the connections are deteriorated. Originally, there was steel cresting that decorated all the ridges and peaks on the building and large tin-coated ridge caps that have since been removed.

*Low Sloped Roof Deteriorated Skirt and Snow Guard*

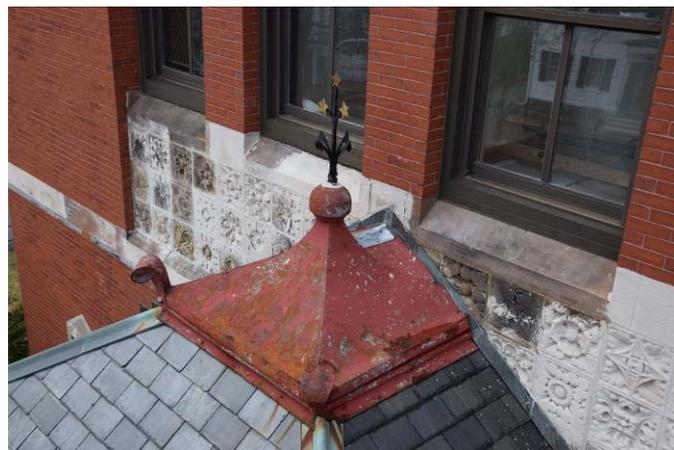
The finials at Abbot Hall are galvanized iron. The galvanization has been failing for a period of time that has allowed the steel to rust. The majority of the finials have a layer of rust on them and have started to stain the adjacent materials. Originally there was steel cresting that adorned all peaks and ridges of Abbot Hall with a heavy galvanized iron ridge. The current iron finials all have patches at the top surface from when the cresting was removed. The iron ridges were removed and replaced with smaller copper ridges. On the portico of the east elevation the only remaining piece of cresting remains. Galvanization has vastly improved since the original galvanized iron was used on Abbot Hall. Replication cresting can be expected to have a much longer service life than the original cresting that was installed.

*Existing Cresting East Portico Peak*

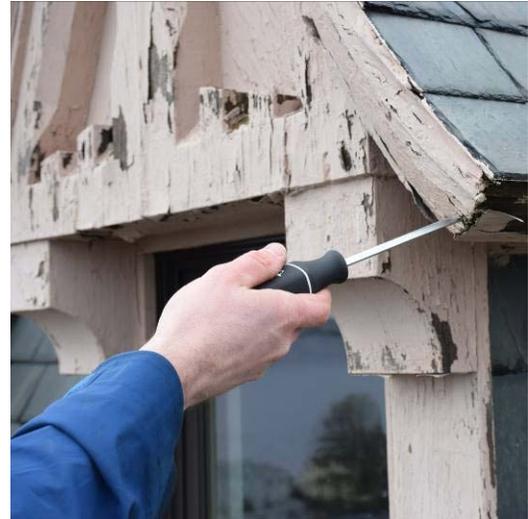
Dormer Wood Trim

There are small dormers on the north south and east elevations of the building. They have wood window trim, casings, brackets and detailing with slate siding on the return walls. All of the wood has very high exposure and is deterioration. The sills of the windows in the dormers have had aluminum installed over the rotten wood. All wood at the dormers should be replaced. The slate needs to be removed and reset for the installation of the new wood.

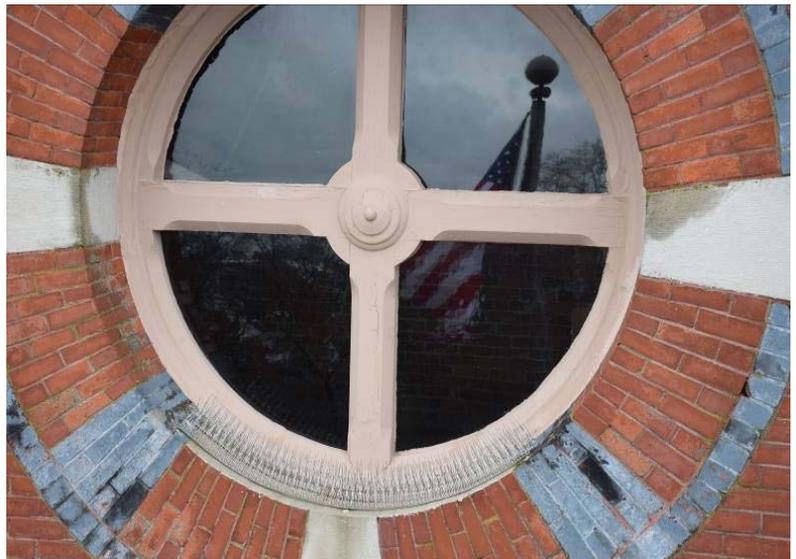
Circular Wood Windows

There are circular wood windows in the gables at the east and west elevations of the buildings. The circular wood window have rotten window frames and casings at the bottoms of the windows. The window sash is in serviceable condition. The frames and casing should have all rotten wood removed, all wood consolidated and restored, and the new glazing compound at all glass. All elements should be prepped primed and painted with new sealant at the perimeter.

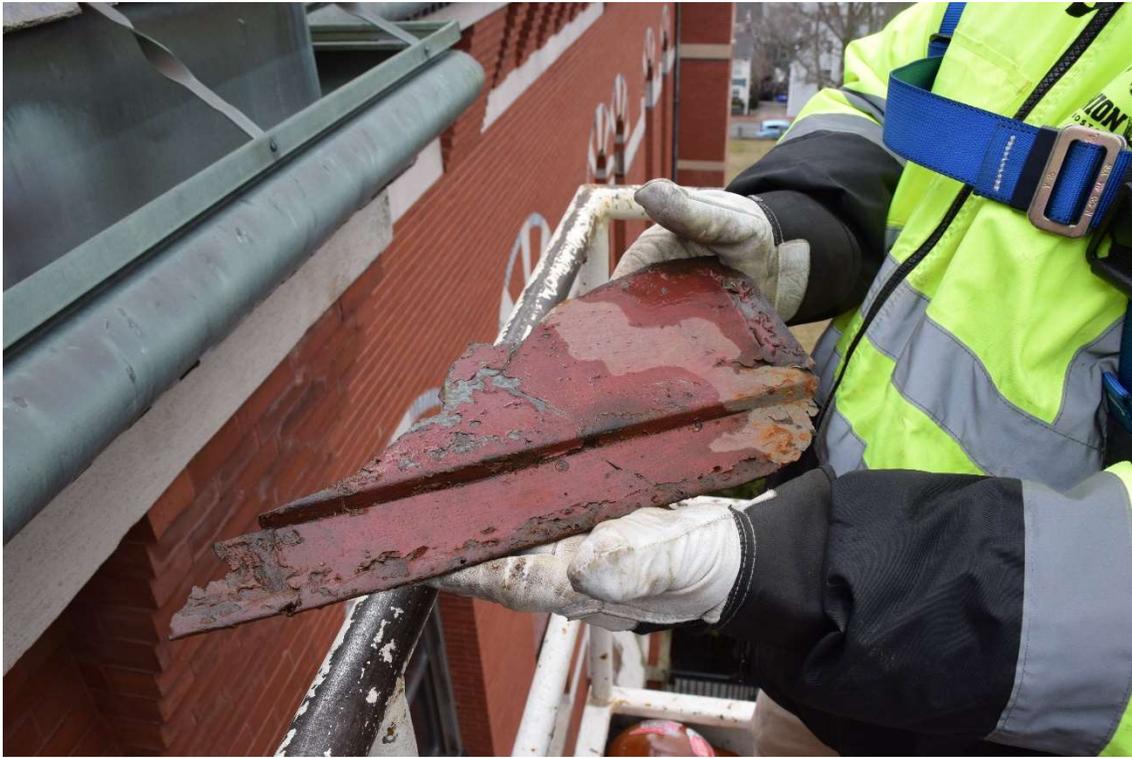
Piece of Finial Found in Gutter

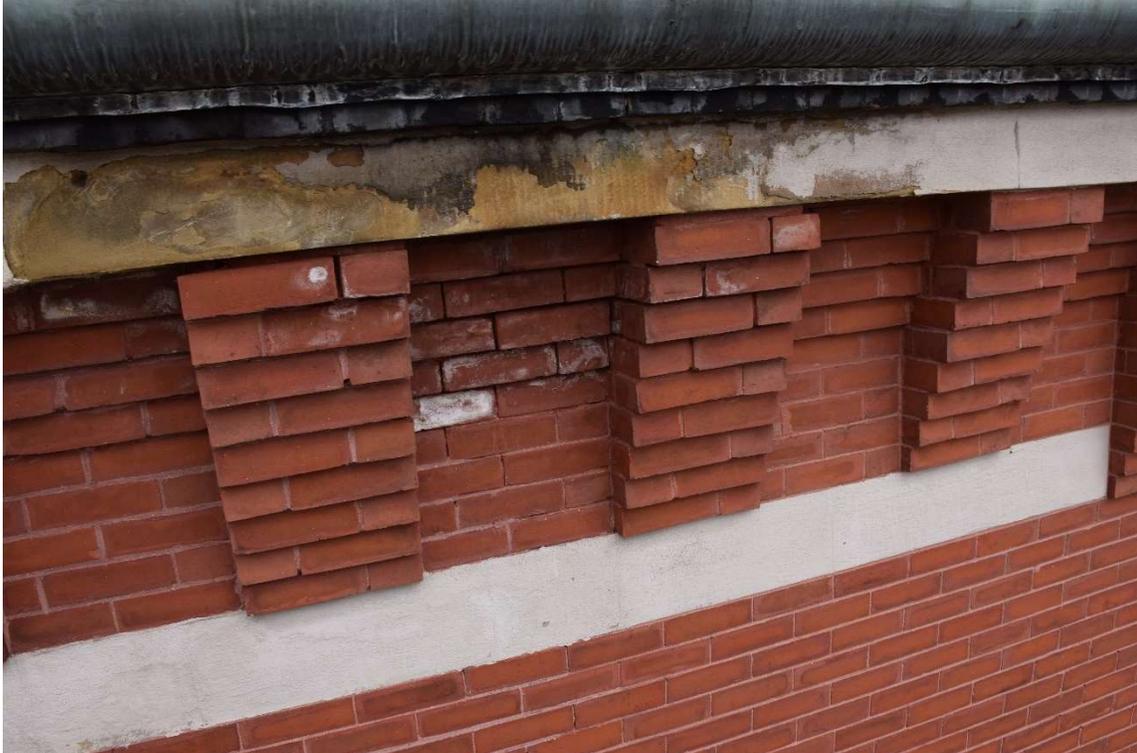
Deteriorated Cornice

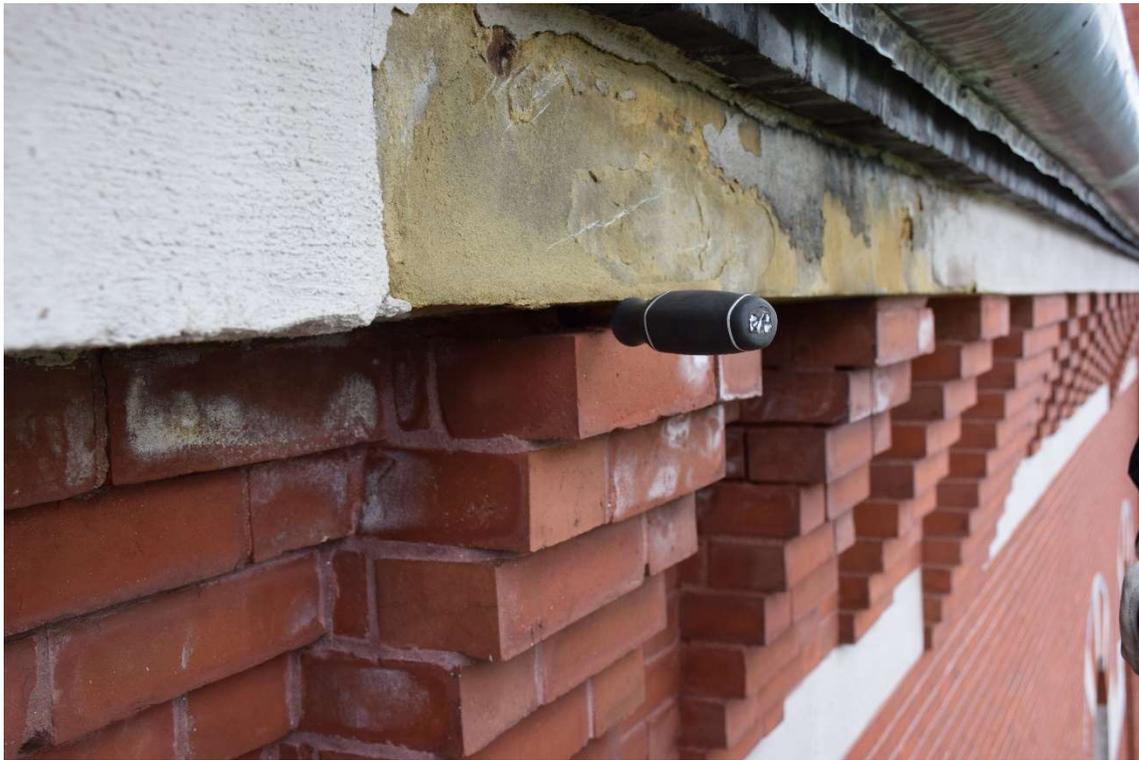
Missing Mortar at Cornice

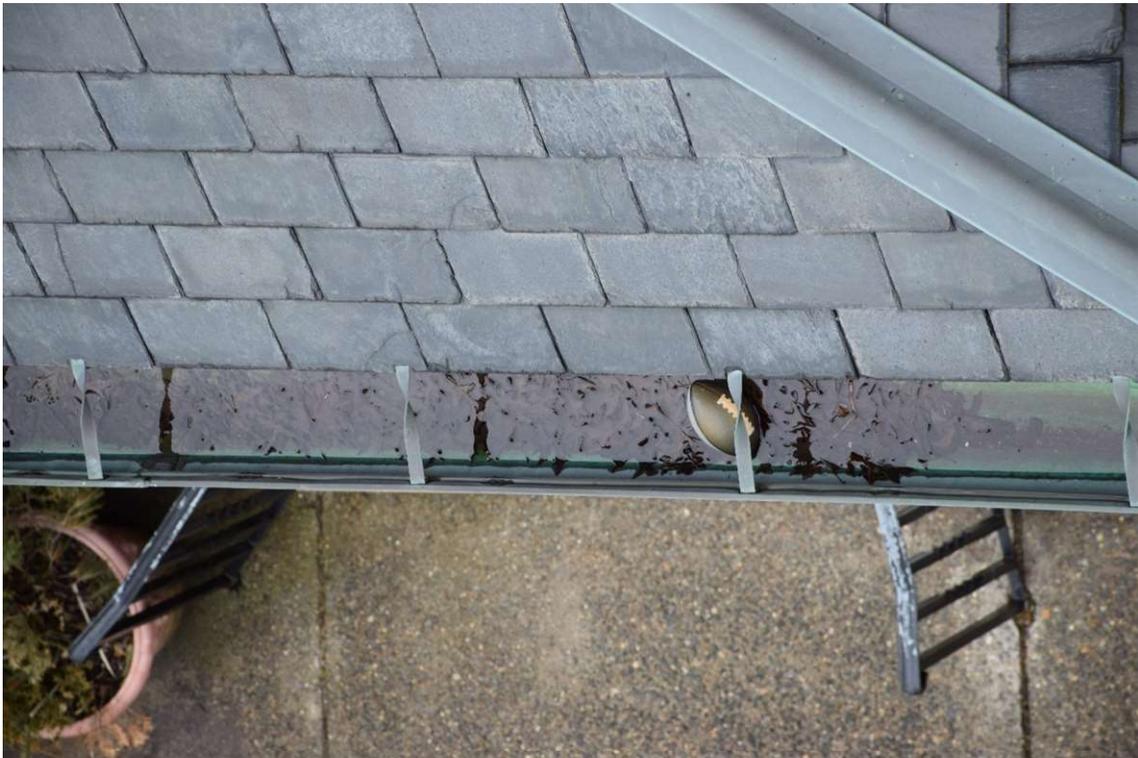
Clogged DS and Gutter with Standing Water

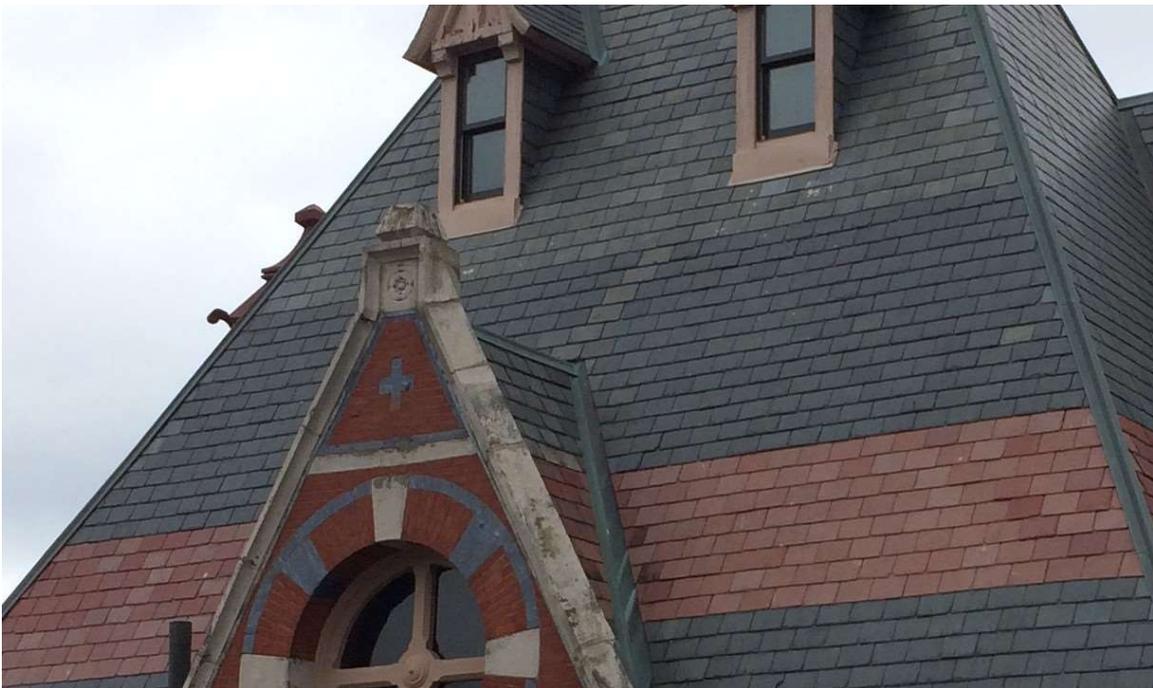
Missing East Elevation Carved Finial

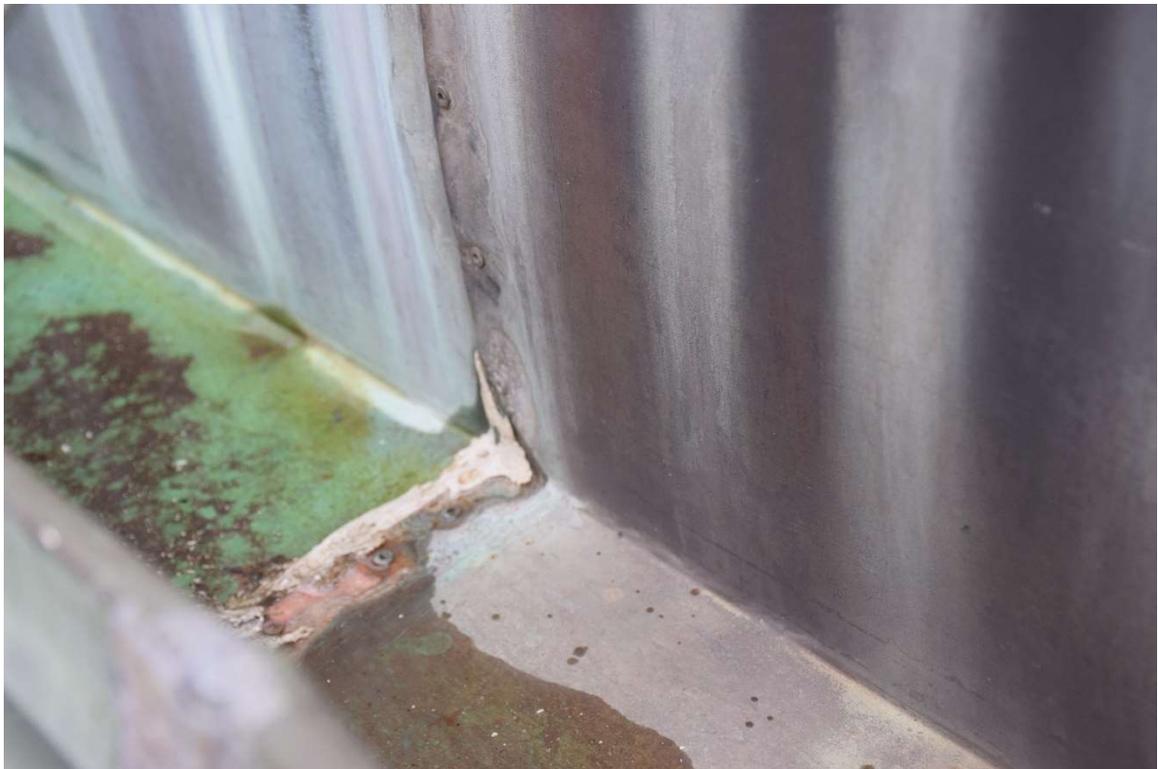
Failed Gutter Patch

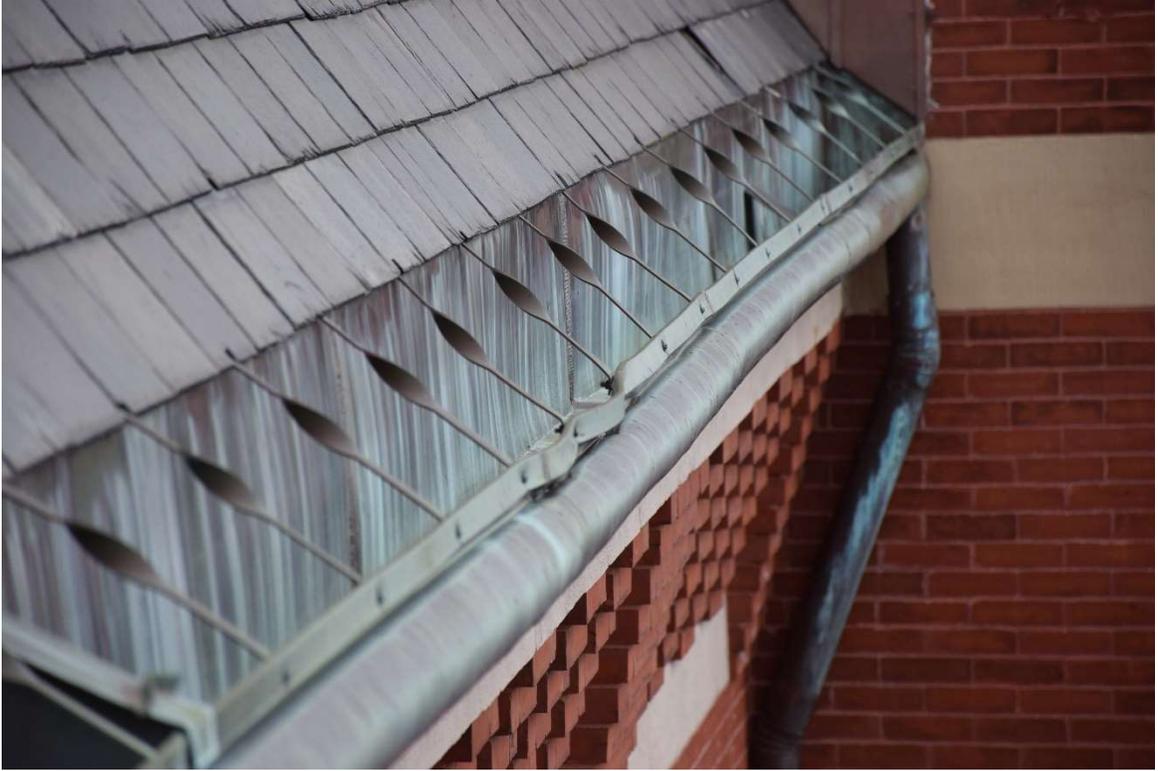
Bent Section of North Gutter

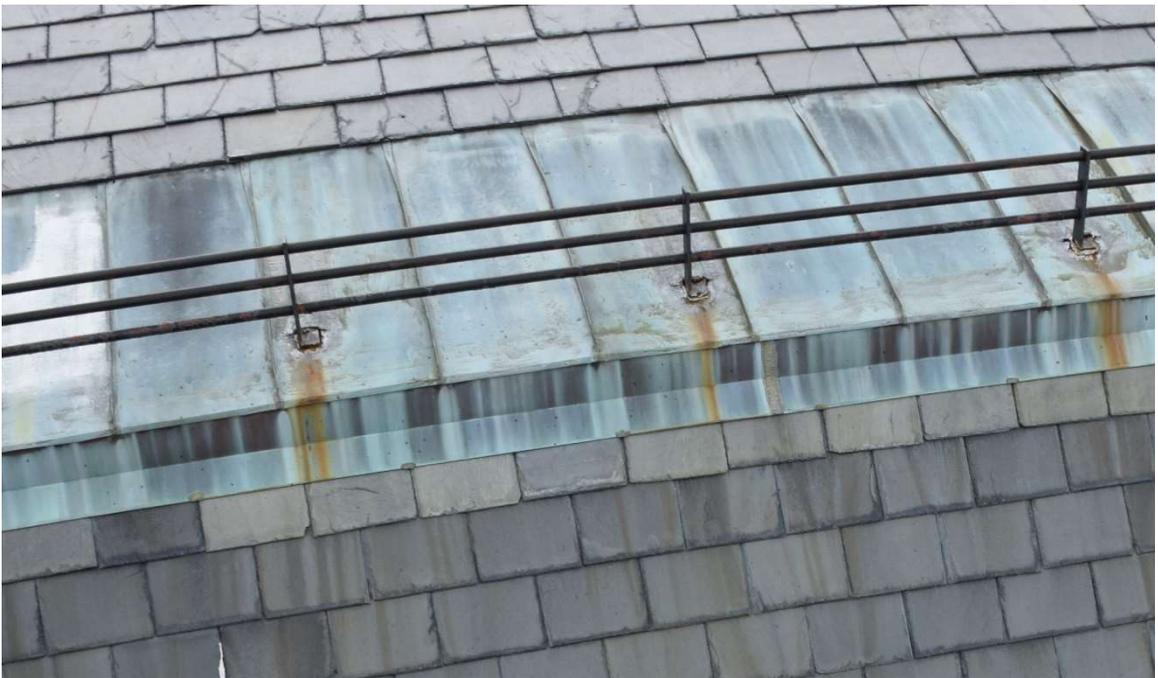
Deteriorated Copper Skirt

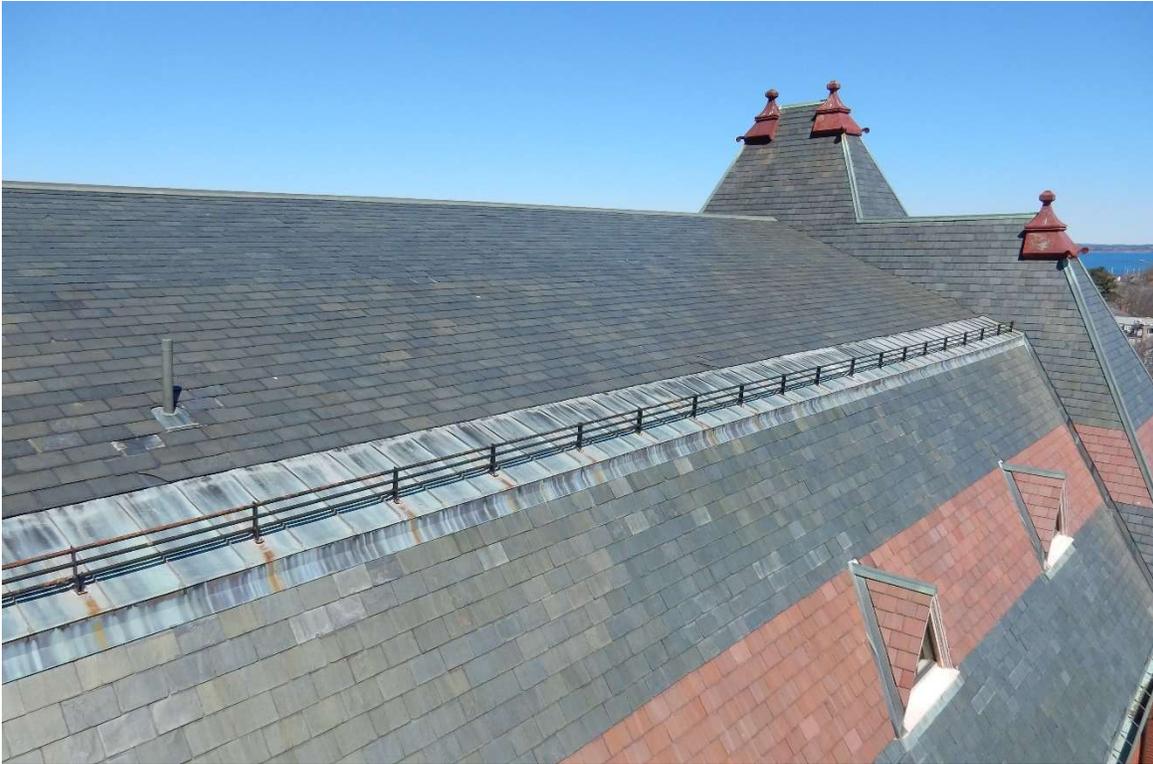
Rusting Skirt and Broken Slate

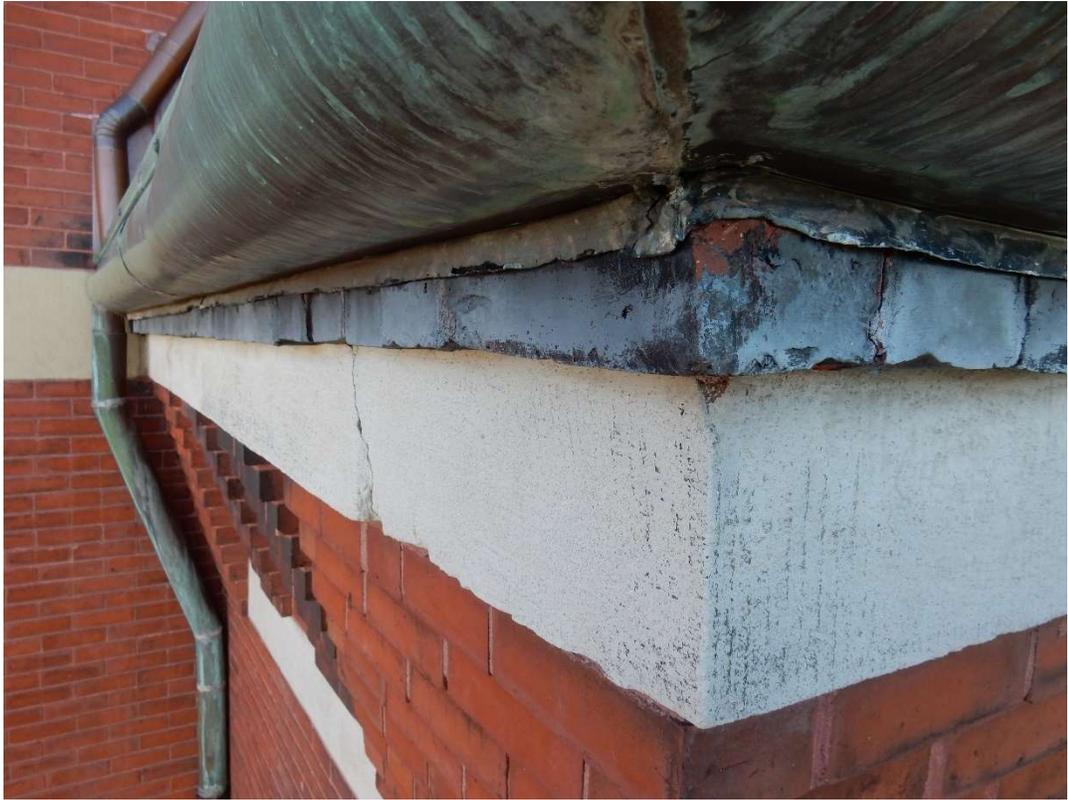
Deteriorated Brick Below Gutter

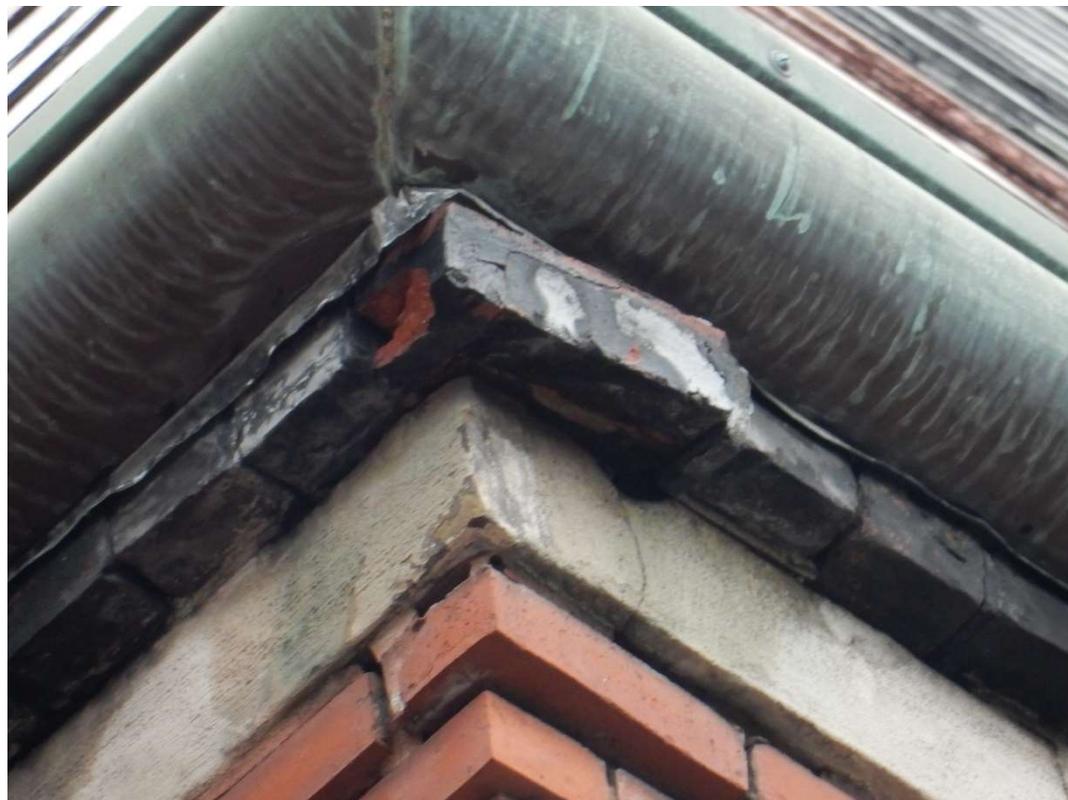
Loose Brick Below Gutter

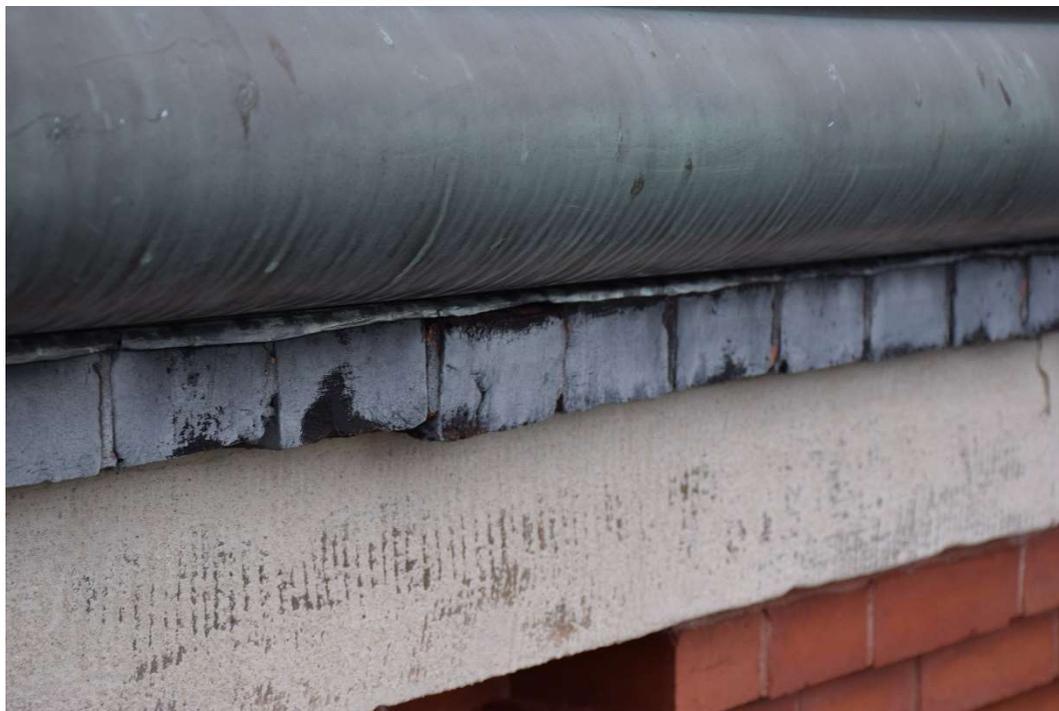
Movement of Brick Below Gutter

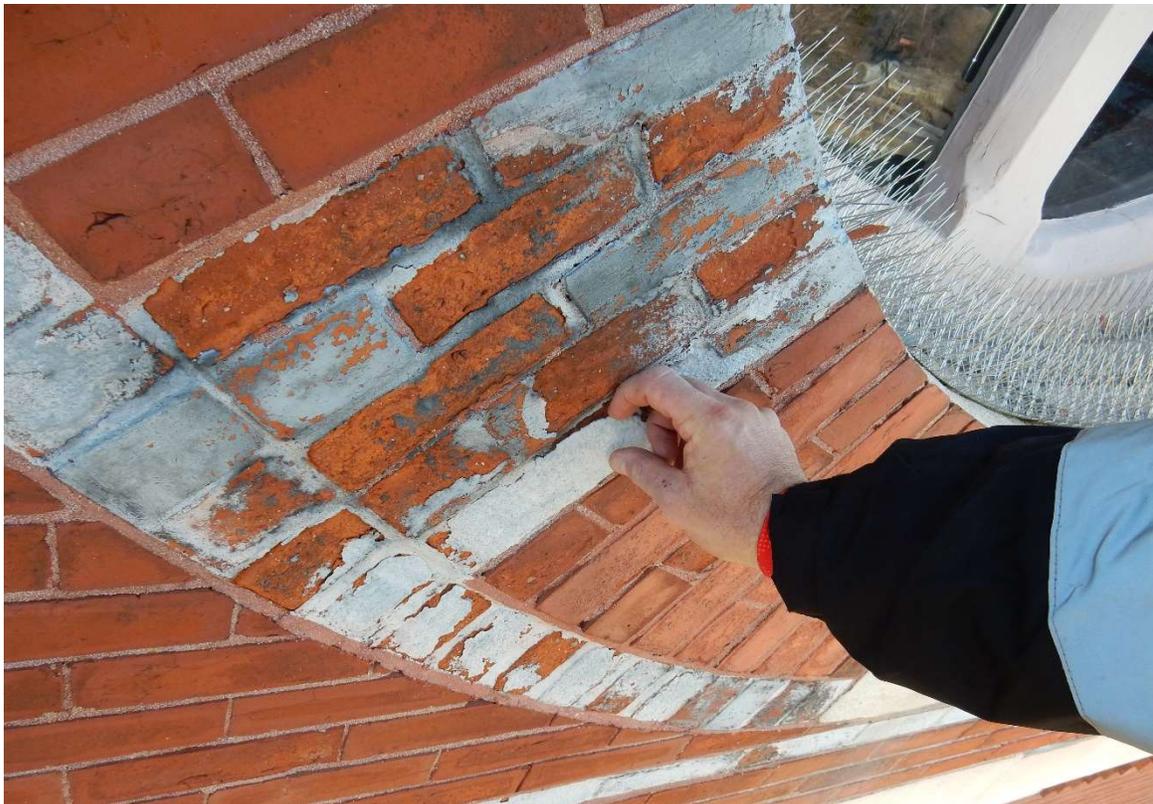
Delamination of Glazed Brick

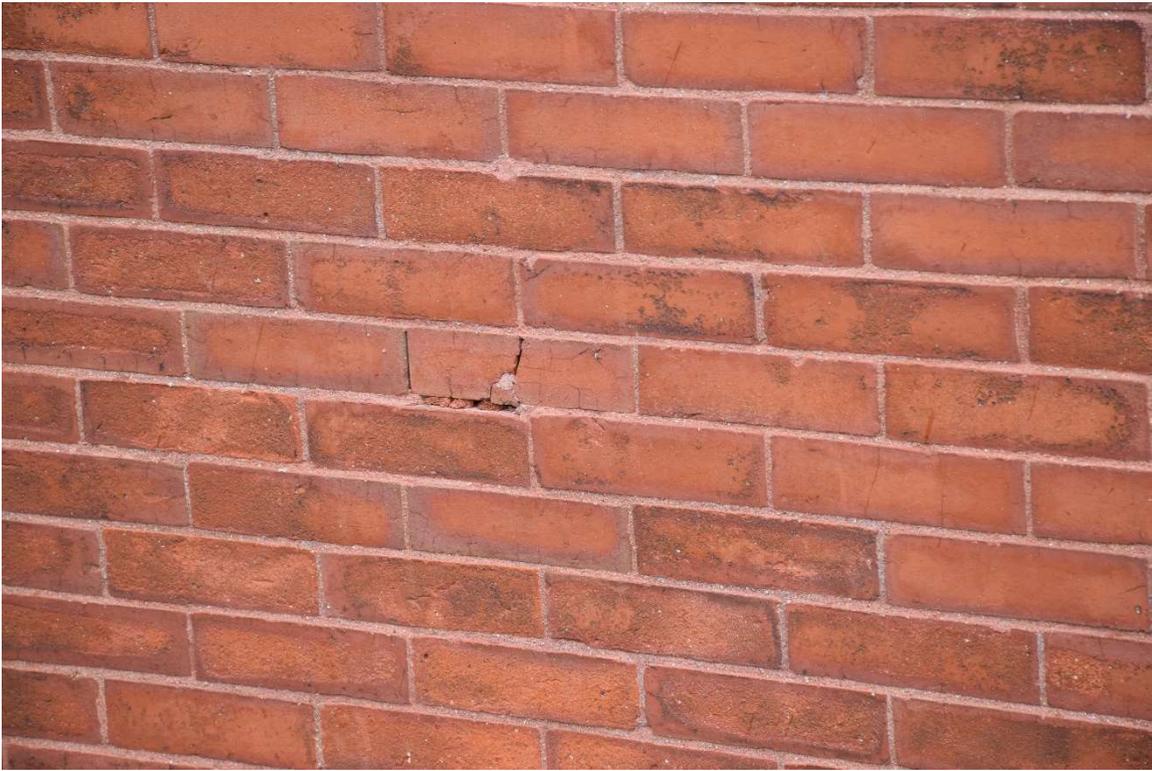
Cracked Brick in Field

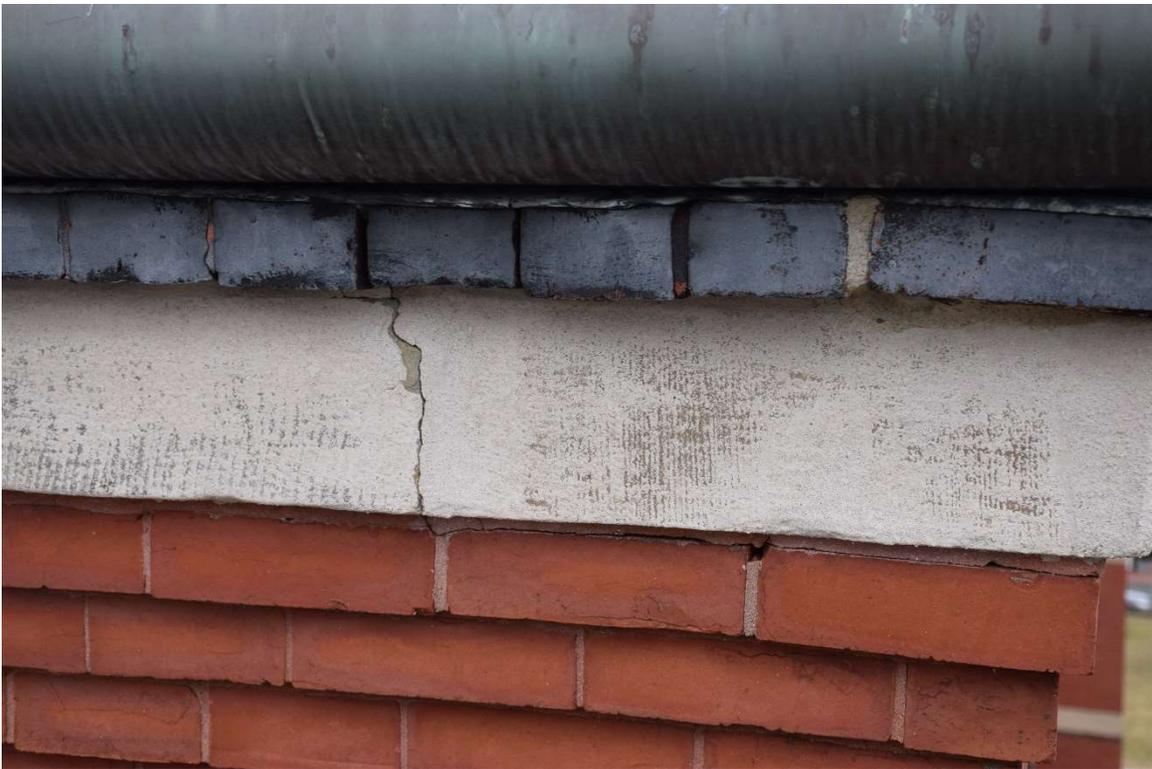
Cracked Sandstone

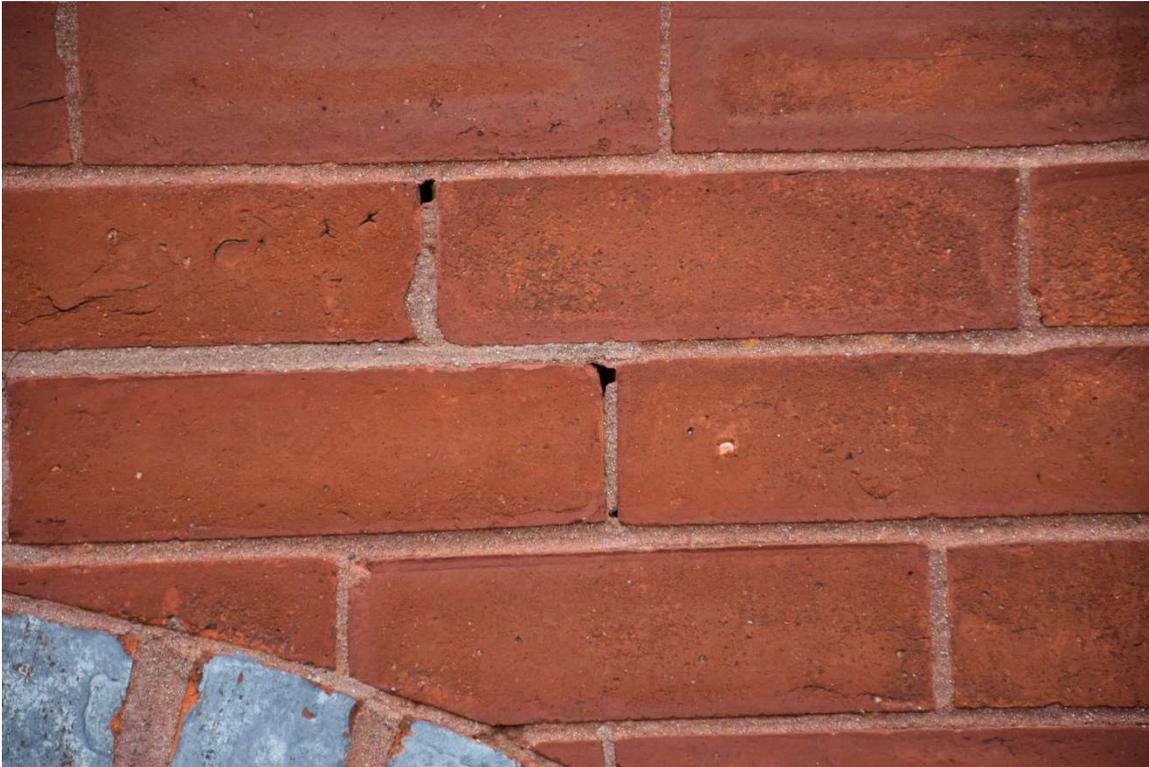
Failed Mortar with Hollow Backup

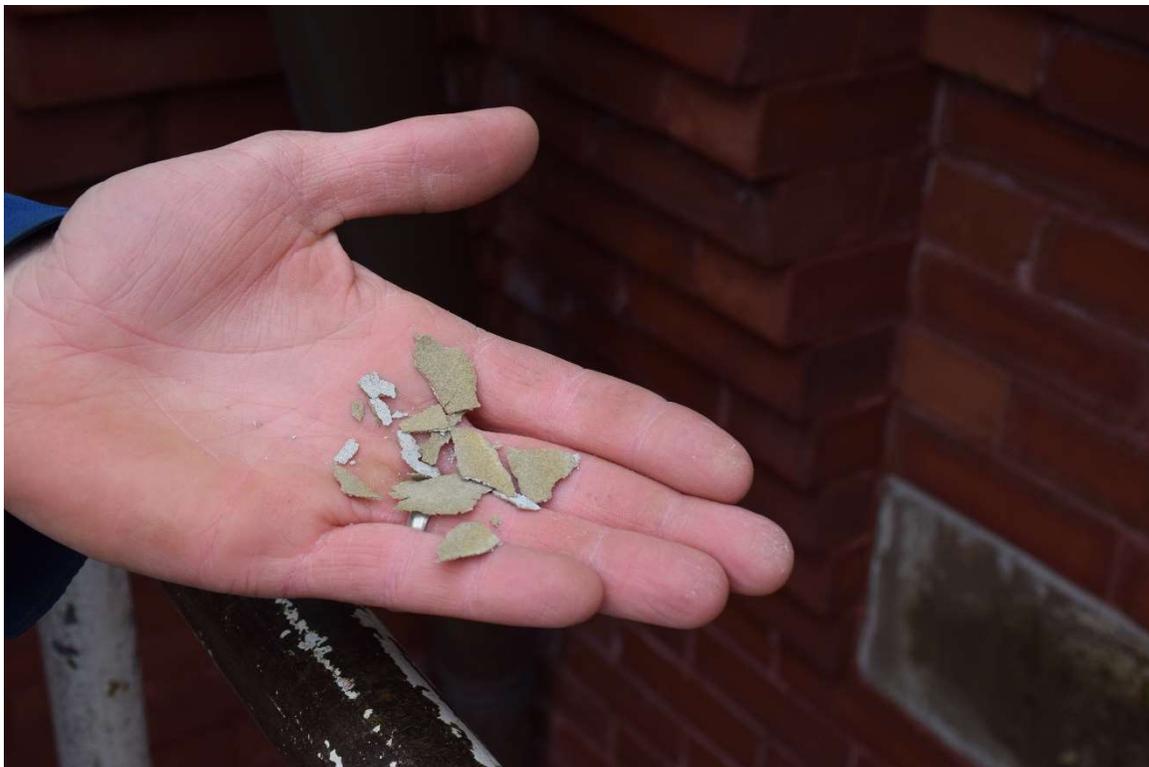
Delamination of Stone Behind Coating
