# Abbot Hall Façade and Grounds Inspection & Assessment Report

Town of Marblehead, Massachusetts

June 30, 2017

# Abbot Hall - Exterior Envelope and Ground Assessment

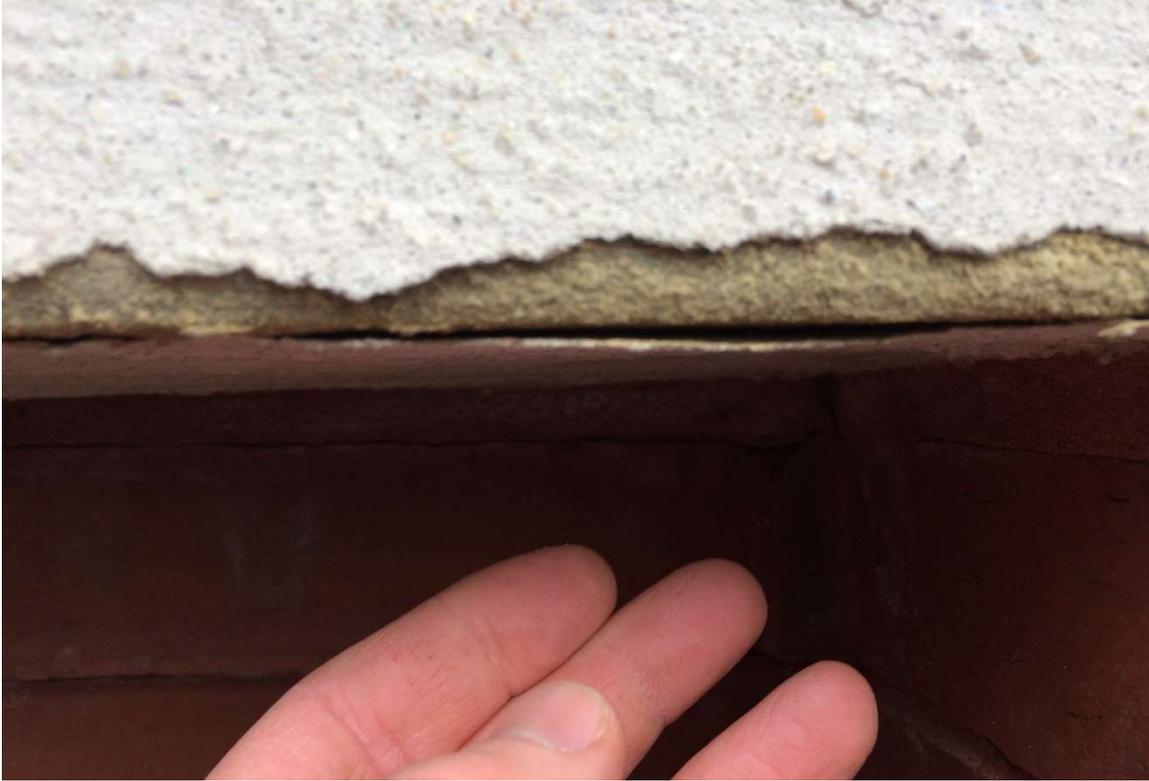
Delamination of Stone Caused by Coating

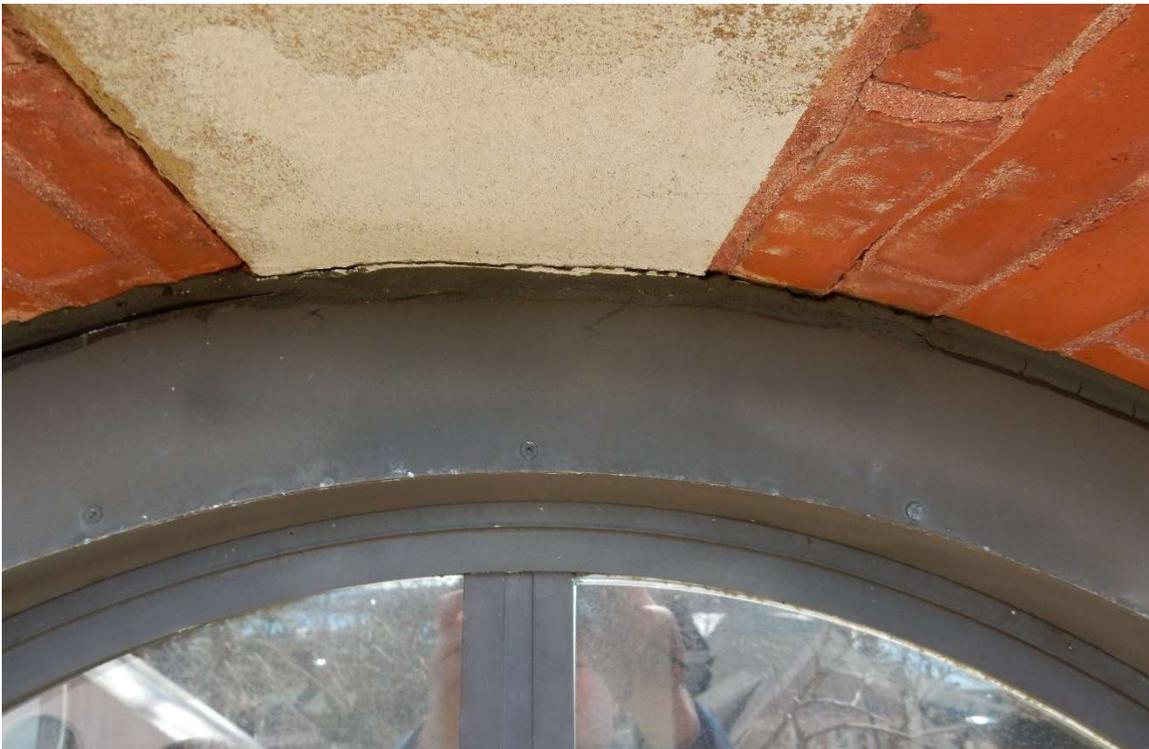
Failed Sealant at Perimeter of Windows

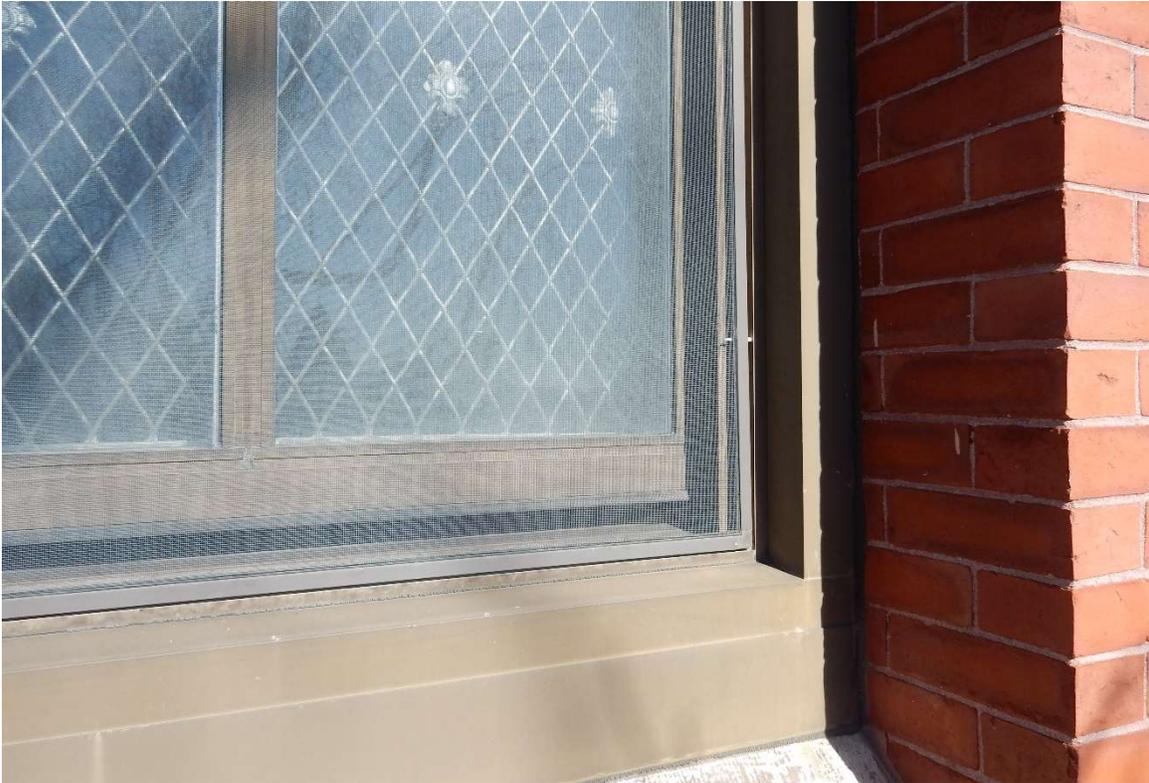
Seal Failure at Window Glass and Window not  
Able to Close

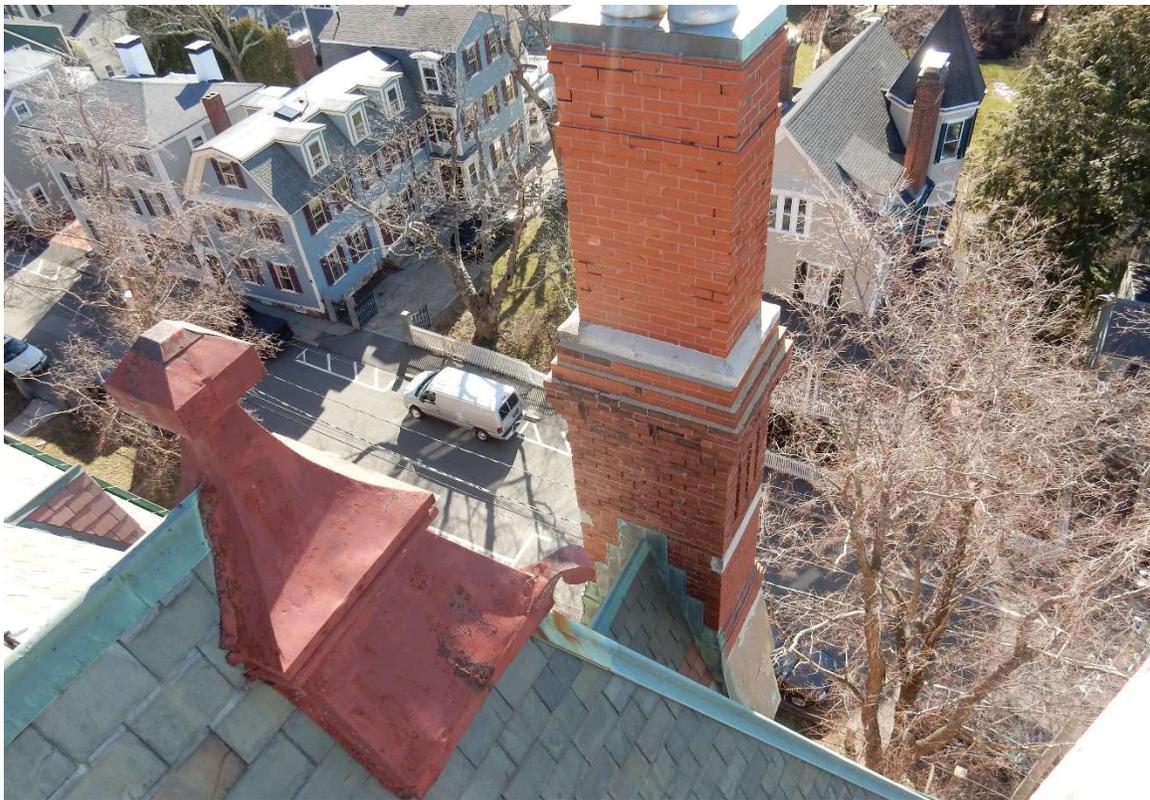
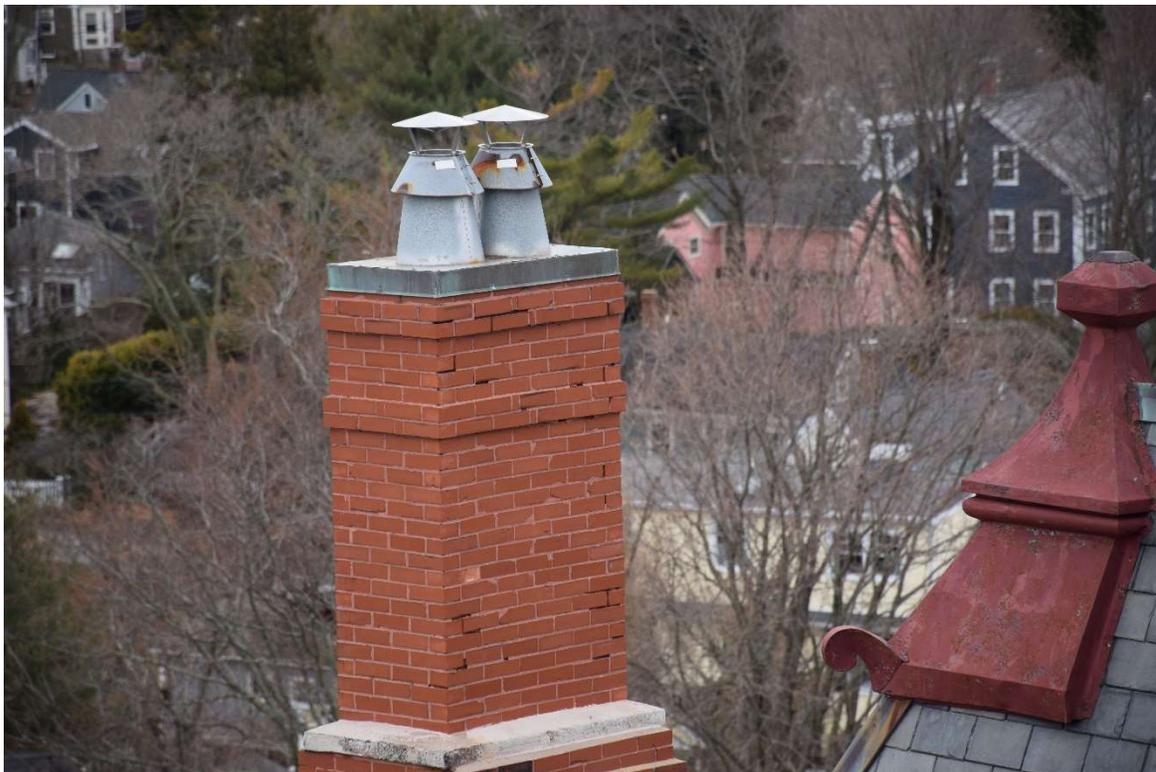
Deterioration at Southwest Chimney

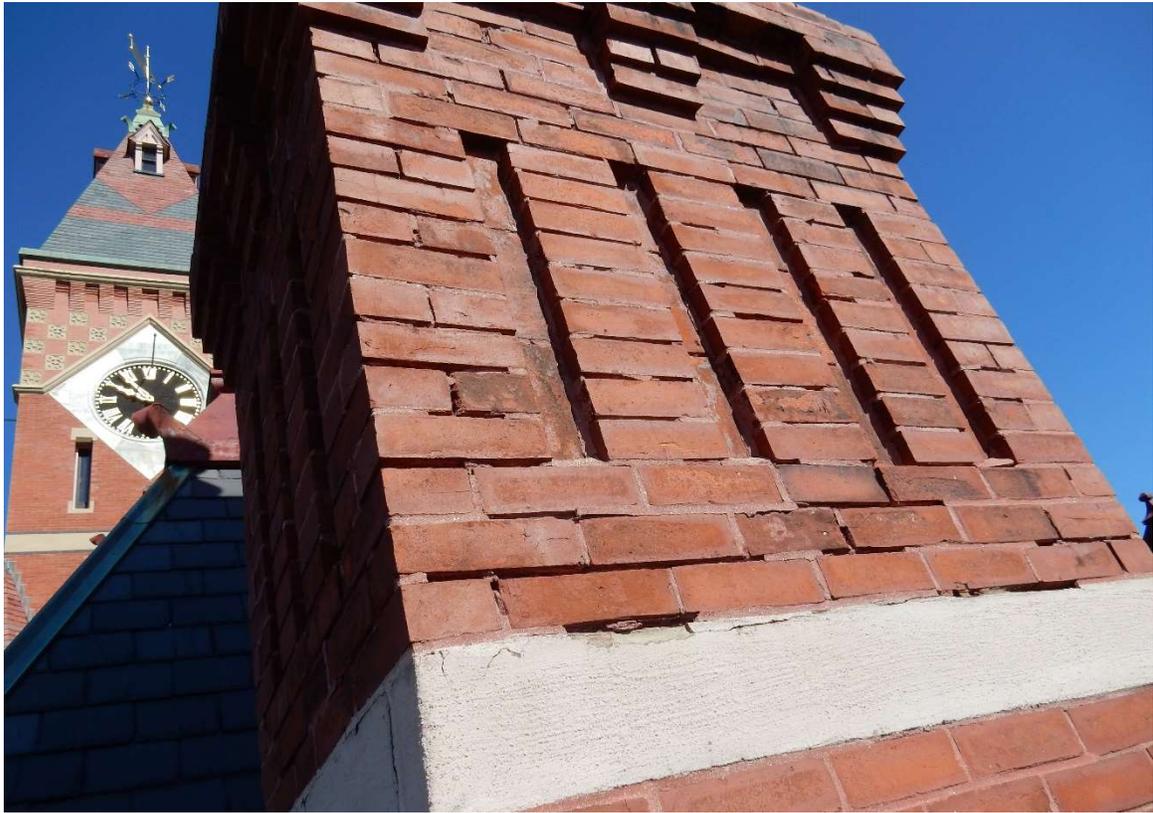
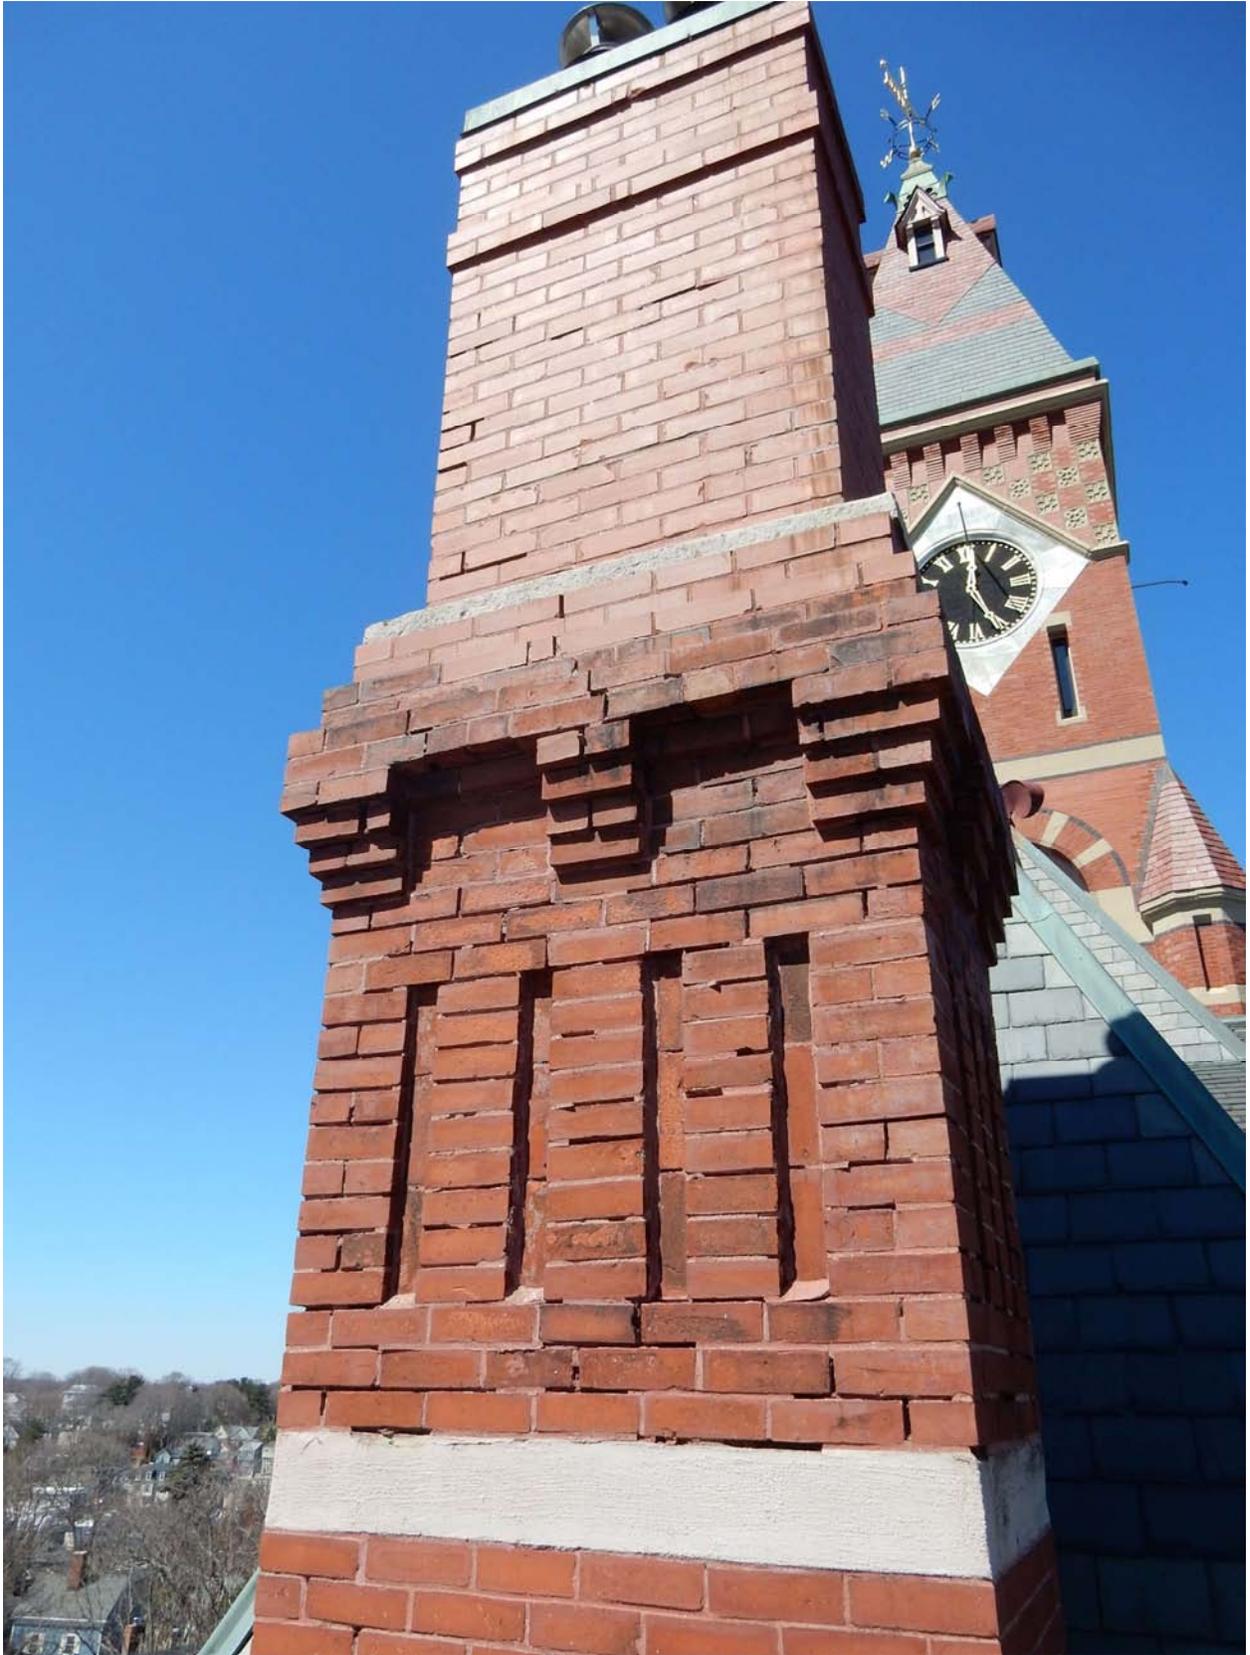
Mortar Failure at Southwest Chimney

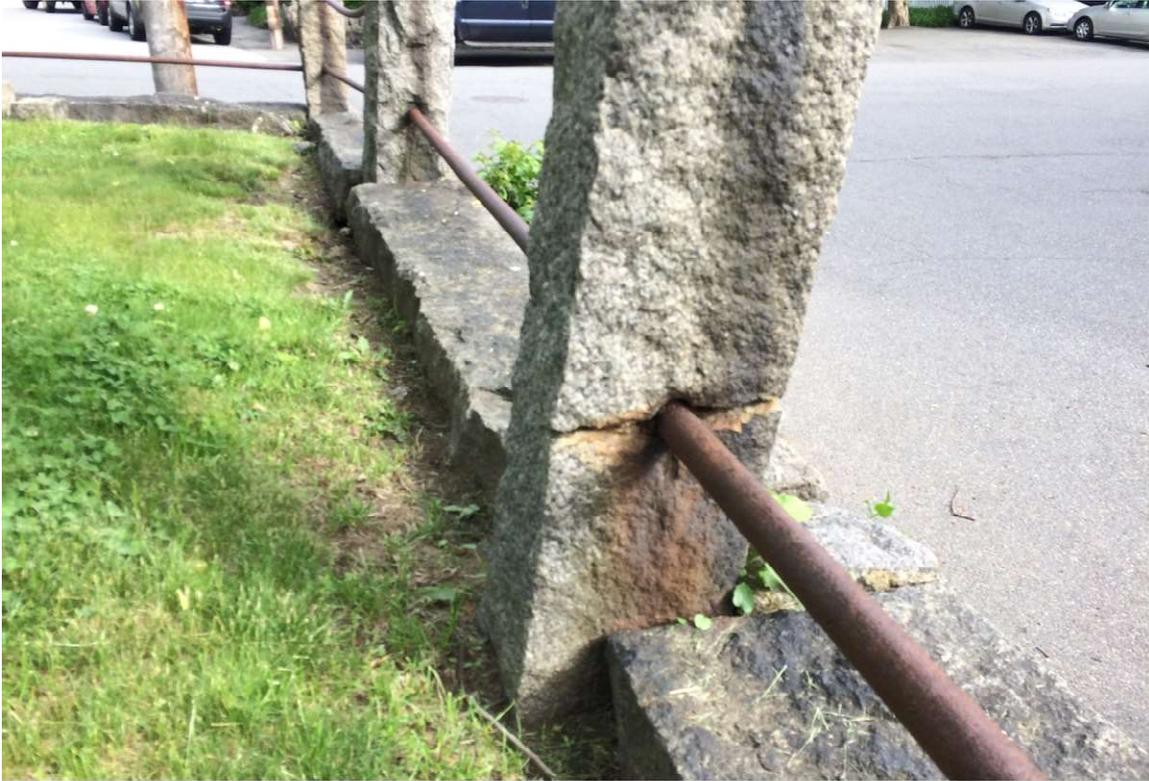
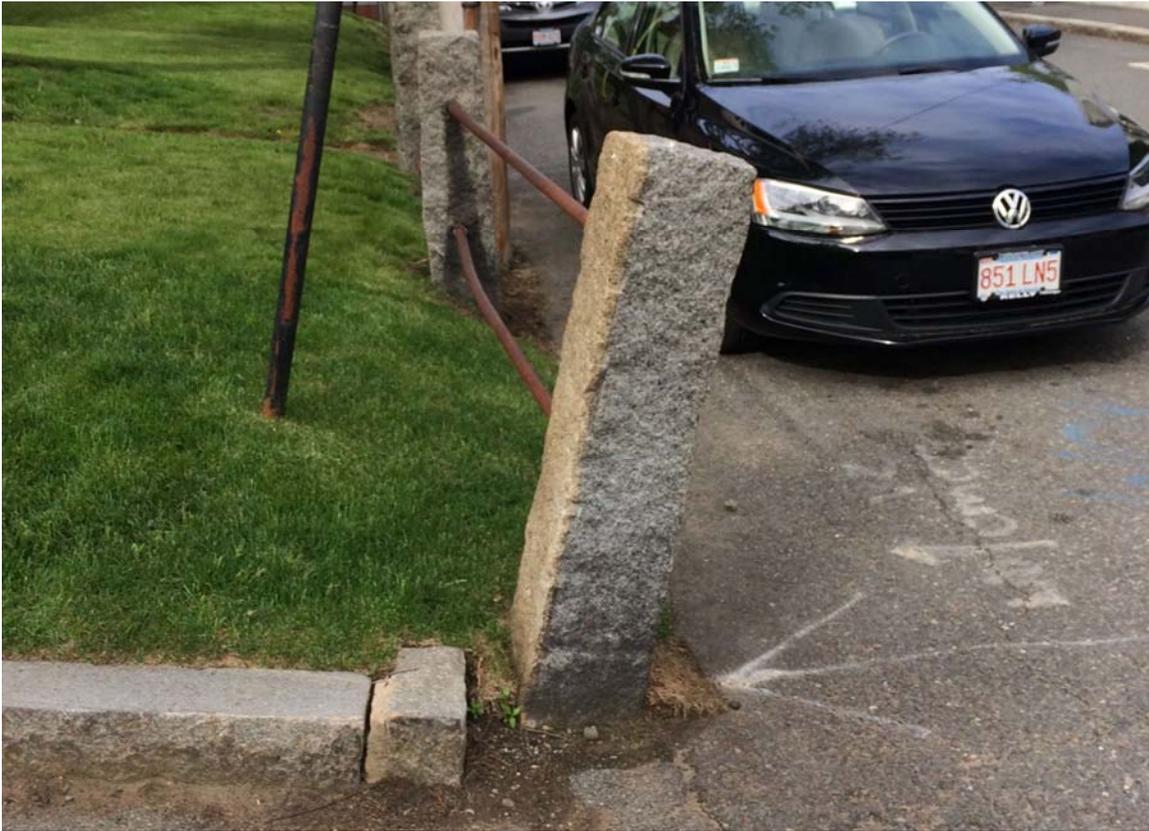
Cracked Granite Post

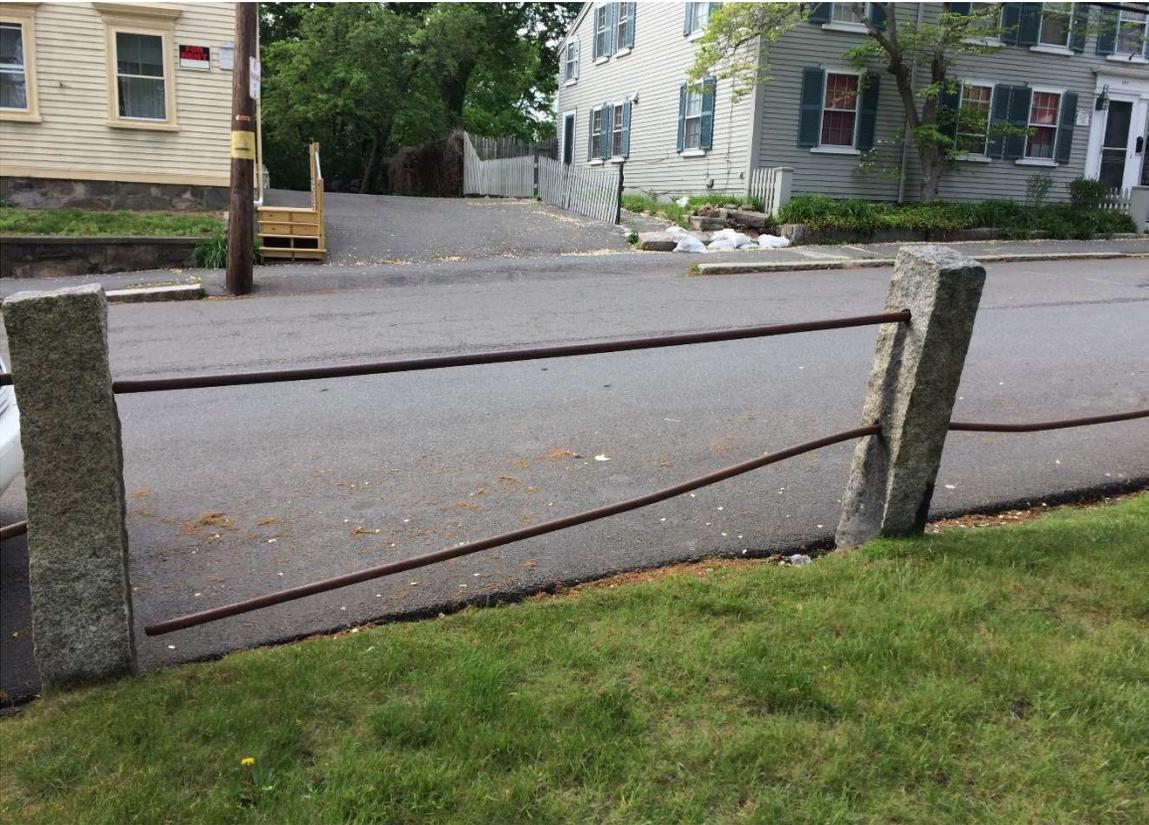
Bent and Dislocated Railing

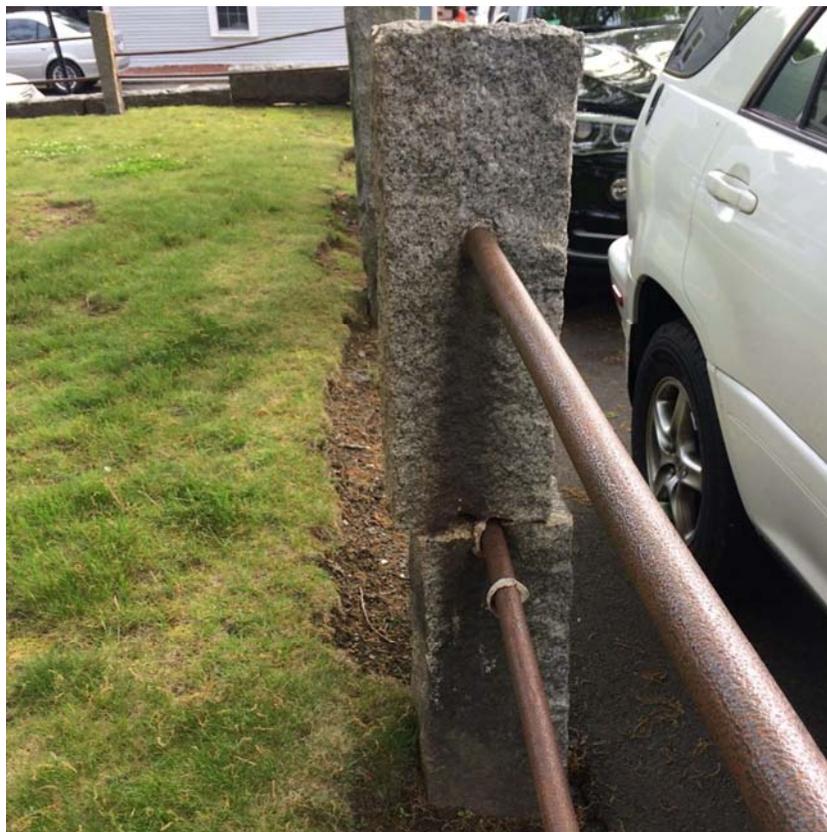
Broken and Displaced Granite Post

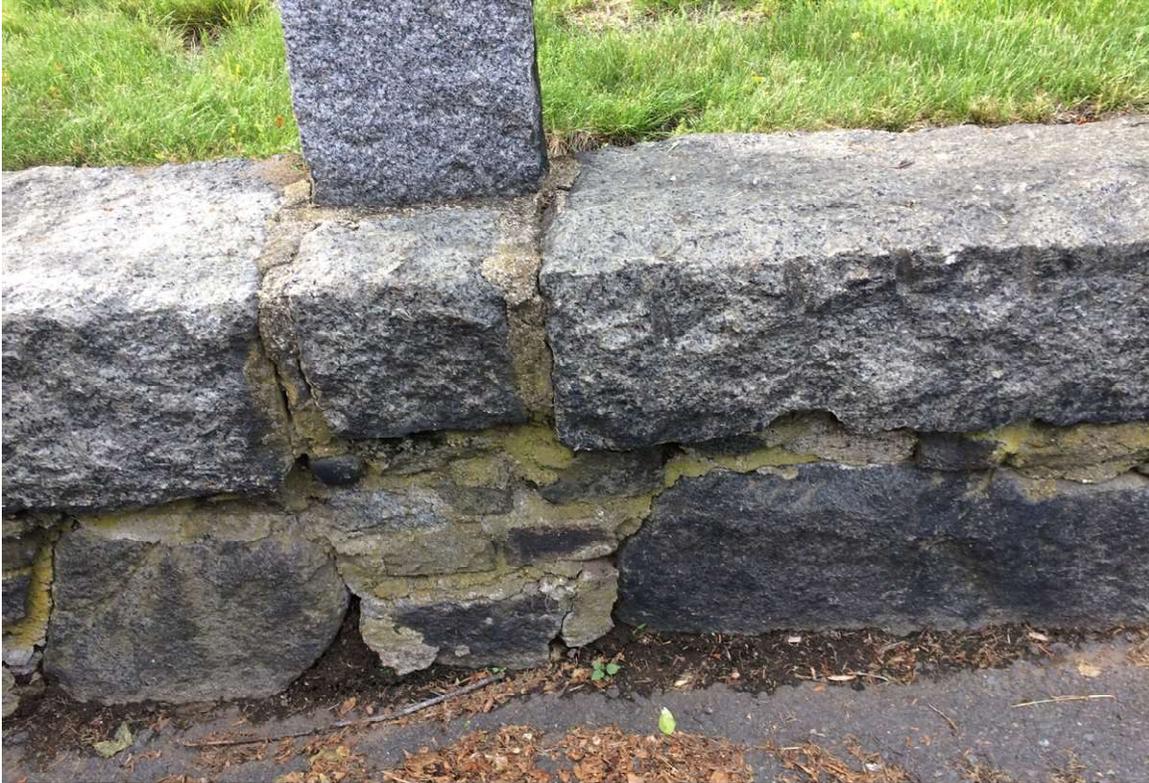
There has been significant movement of the stones of the site wall. The wall is still stable, but a majority of the mortar is missing. There is a large granite cap stone that has provided protection to the rubble wall below.

Failed Mortar at Granite Site Wall

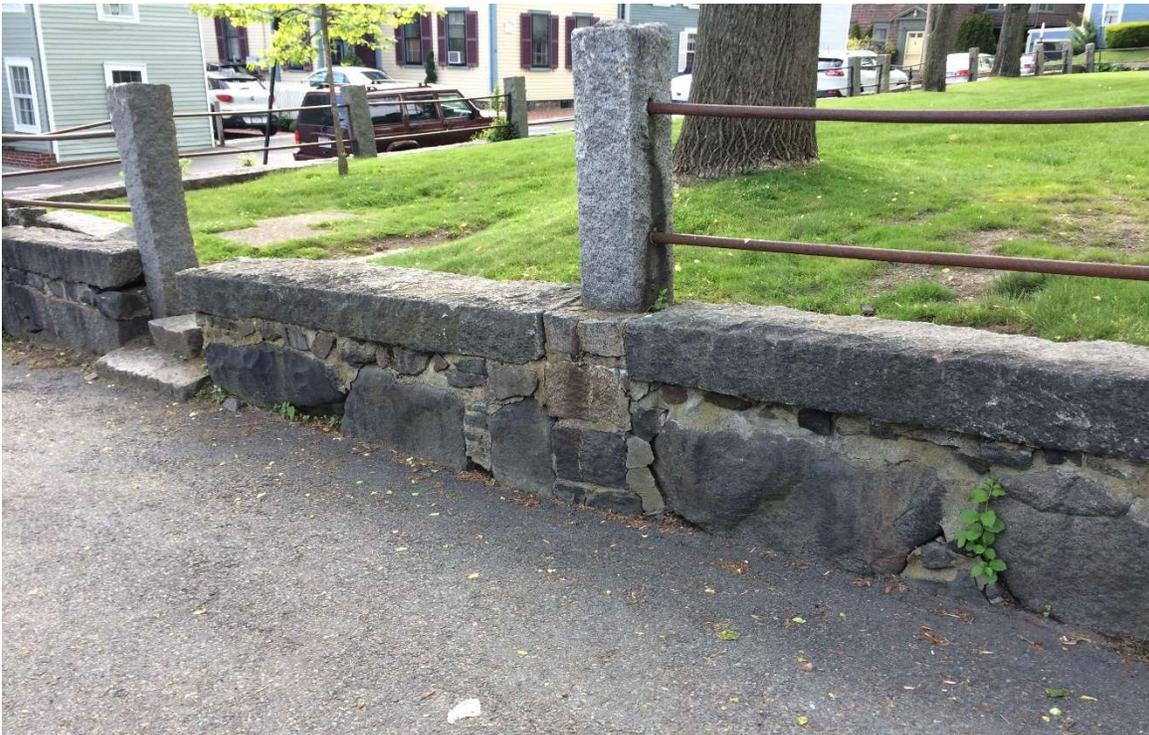
Movement of Stones at Granite Site Wall

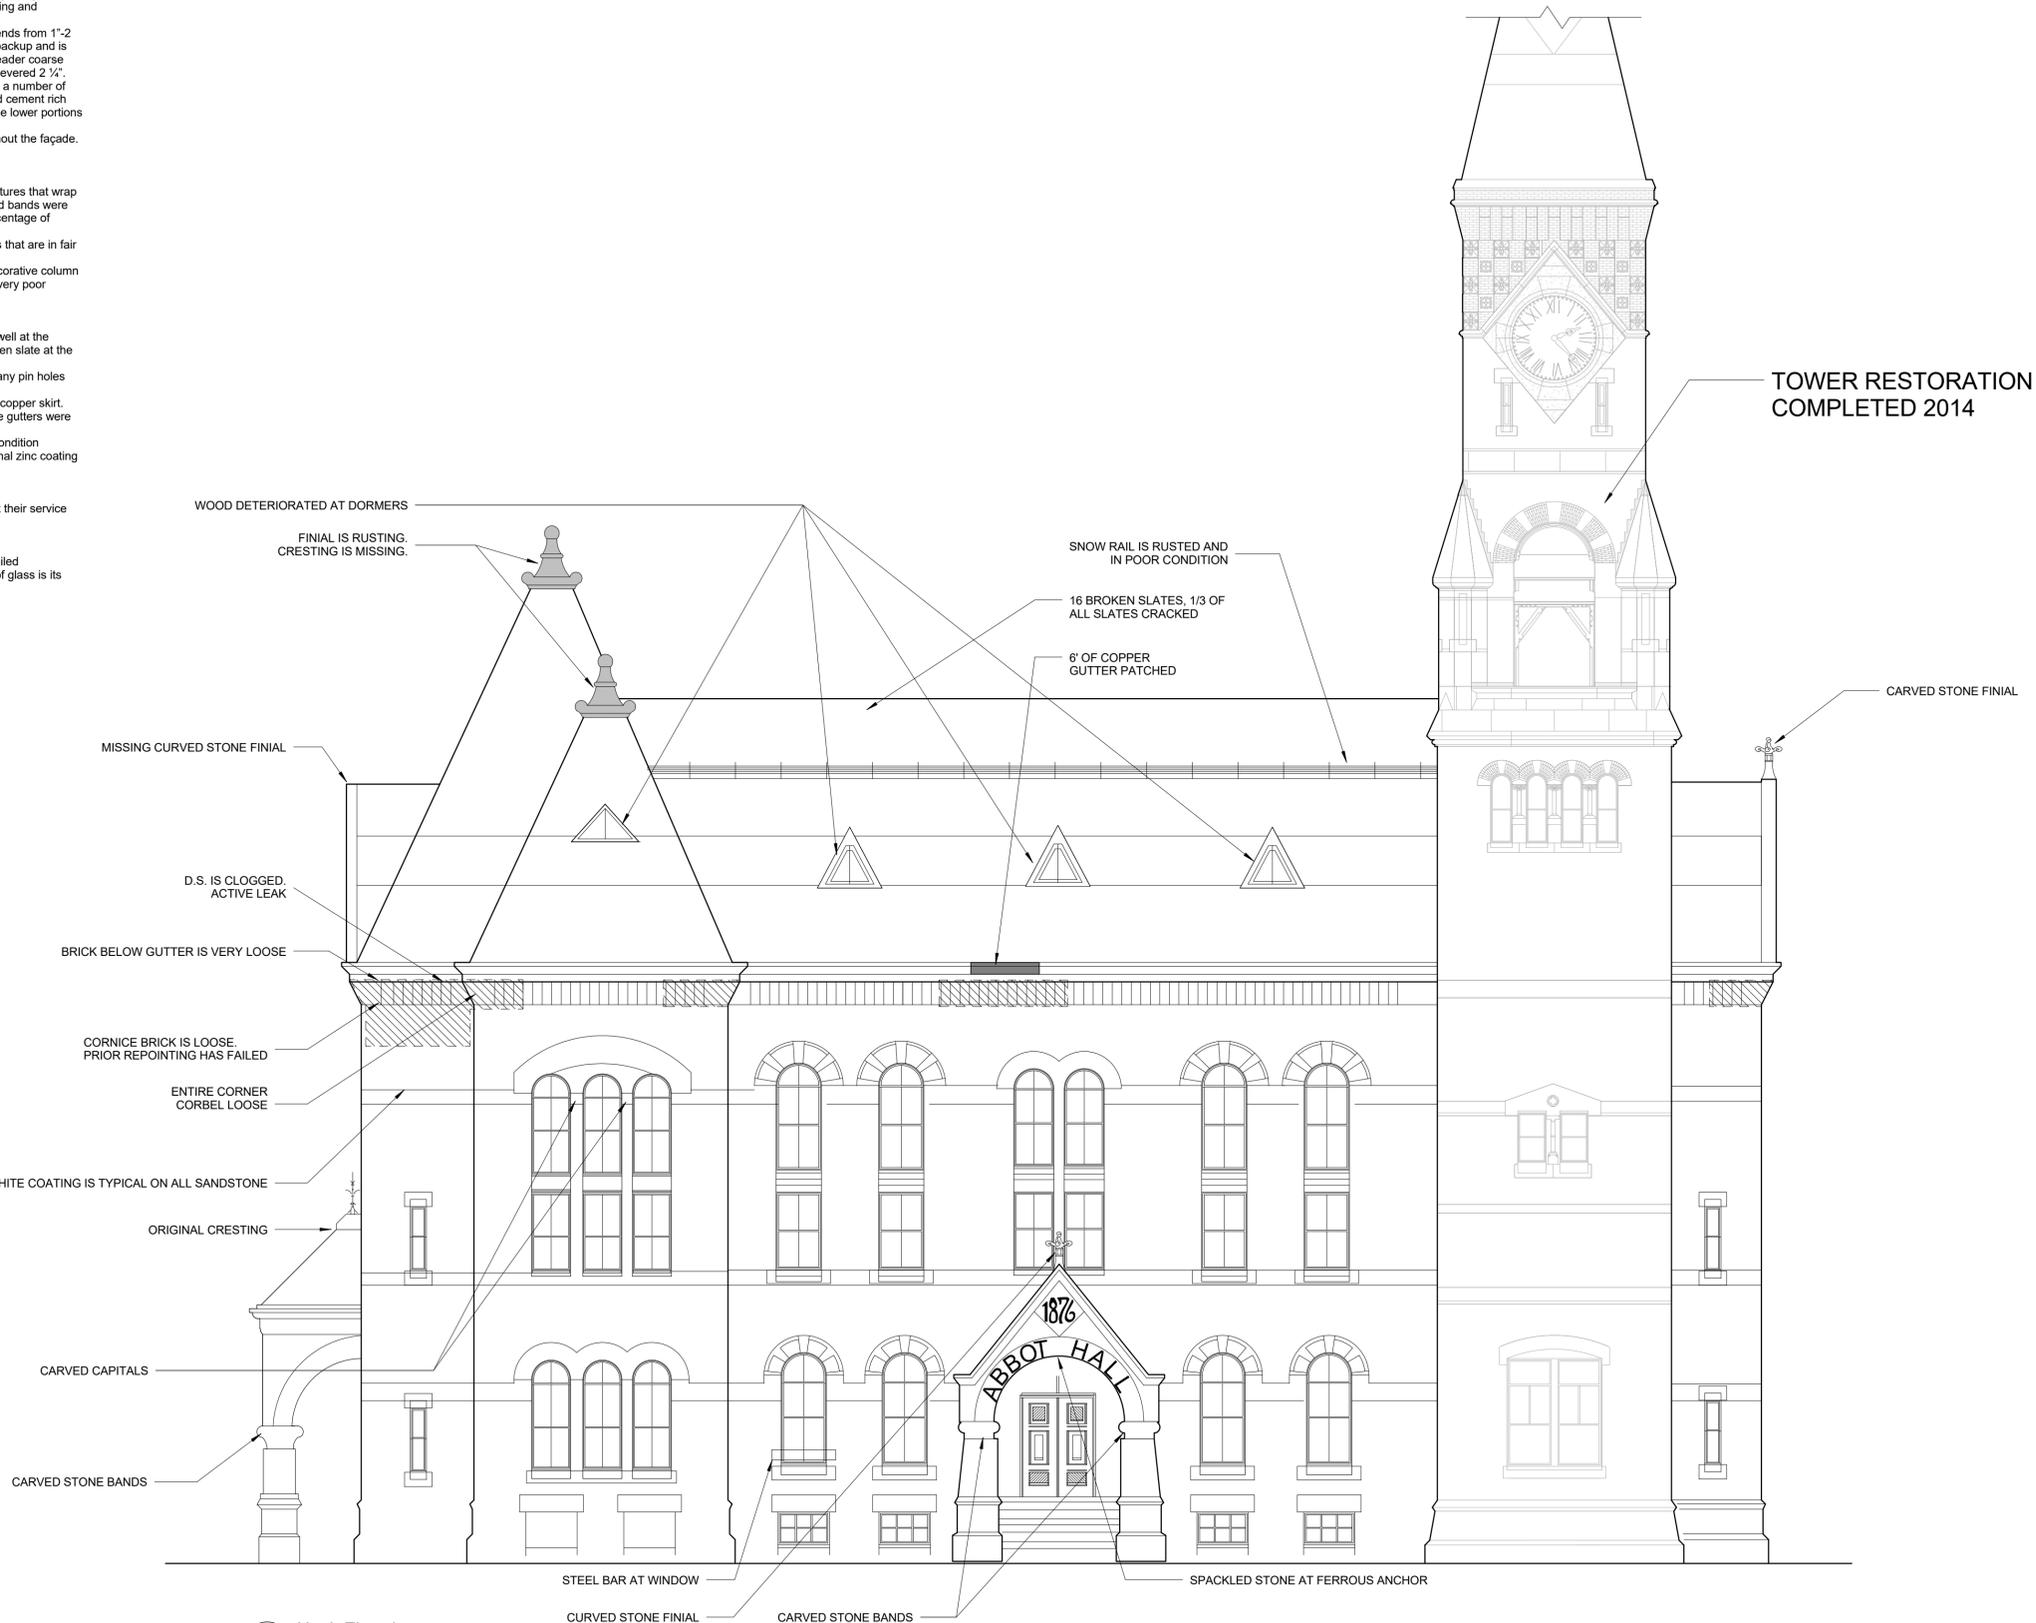
1 North Elevation  
1/8" = 1'-0"

- The chimney on the south elevation is in very poor condition. All mortar joints have failed. An extension was built on top of the original chimney and is in very poor condition as well. The brick are in loose and unstable condition.

- The nova scotia sandstone has been covered with a white coating designed for concrete sidewalks. All areas of sandstone are experience sugaring and deterioration

- Below the gutter there is a single header course of brick that extends from 1'-2 1/4" beyond the brick below. This course of brick was set with no backup and is loose in all locations. At the outside corners of the building the header course becomes a soldier course and the 3 1/2" width of the brick is cantilevered 2 1/4".

- The field of brick is generally in good condition. There have been a number of areas that have previously been repointed with improper Portland cement rich mortars. There are vertical cracks that extend through brick on the lower portions of the building.

- Black glazing on brick was used as a decorative element throughout the façade. This glazing is deteriorated and many of the bricks are cracked.

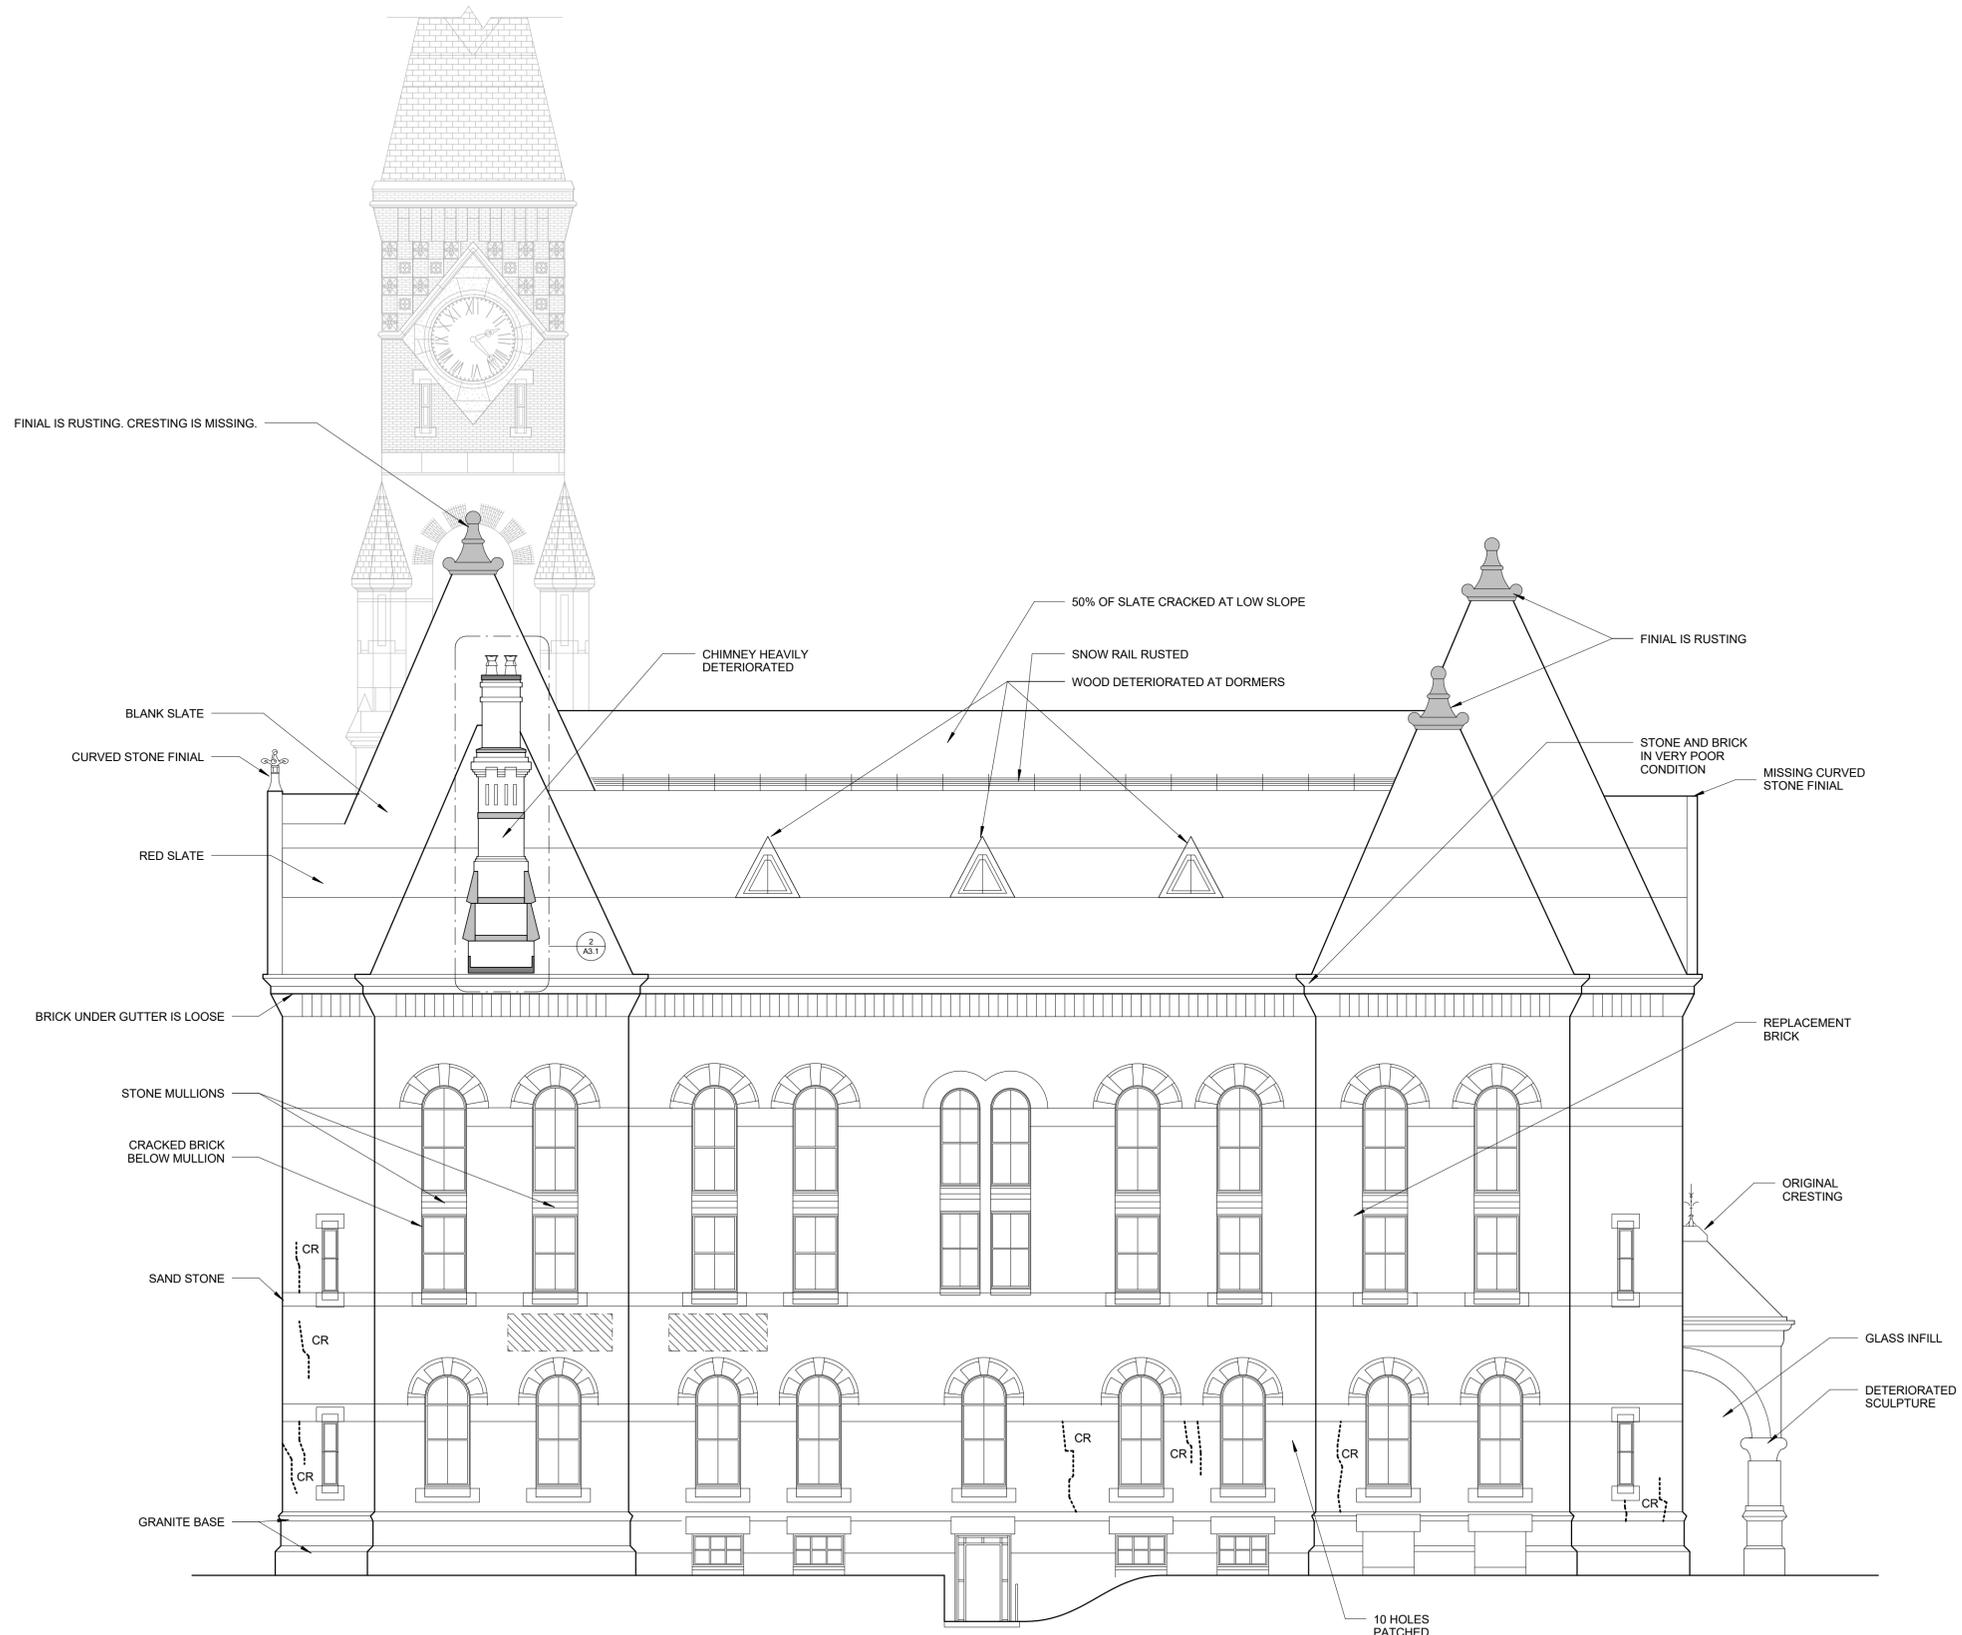
1 South Elevation  
1/8" = 1'-0"

- The chimney on the south elevation is in very poor condition. All mortar joints have failed. An extension was built on top of the original chimney and is in very poor condition as well. The brick are in loose and unstable condition.

- The nova scotia sandstone has been covered with a white coating designed for concrete sidewalks. All areas of sandstone are experience sugaring and deterioration

- Below the gutter there is a single header course of brick that extends from 1'-2 1/4" beyond the brick below. This course of brick was set with no backup and is loose in all locations. At the outside corners of the building the header course becomes a soldier course and the 3 1/2" width of the brick is cantilevered 2 1/4".

- The field of brick is generally in good condition. There have been a number of areas that have previously been repointed with improper Portland cement rich mortars. There are vertical cracks that extend through brick on the lower portions of the building.

- Black glazing on brick was used as a decorative element throughout the façade. This glazing is deteriorated and many of the bricks are cracked.
