PERMITEE-OWNED PROPERTY INVENTORY AND GREEN INFRASTRUCTURE RETROFIT PLAN

Marblehead, MA

June 2022

Bobrek Engineering & Construction, LLC

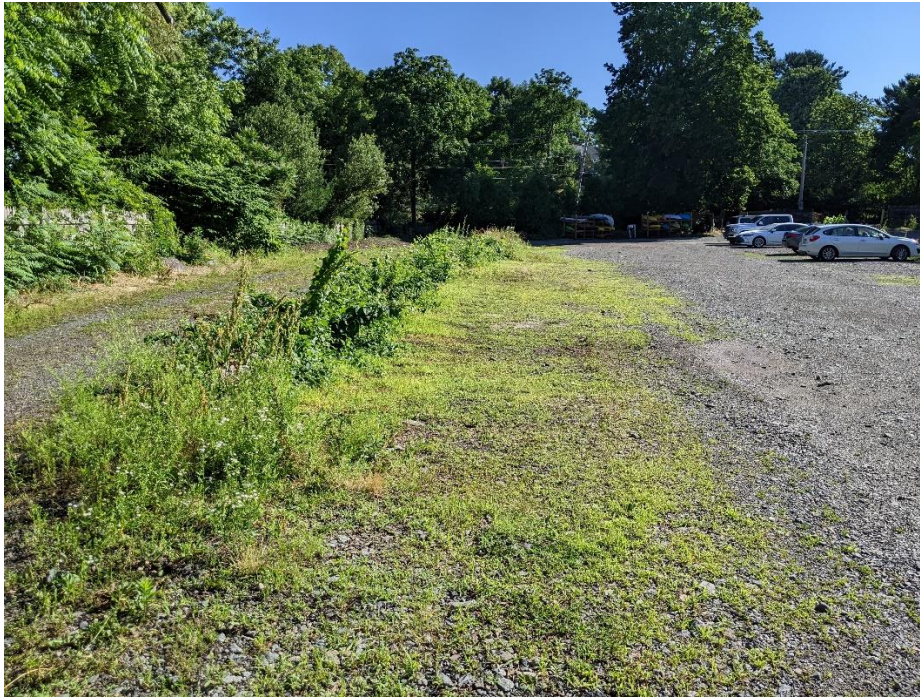
This parking lot is the parking area for the Village Street Public Landing. It is a large gravel parking lot that slopes towards the neighboring property which has experienced flooding in the past as a result. There are three catch basins that are unmapped in the Marblehead GIS system on the site. The catch basins are likely to connect to those in the street that drain to OF29 (Previous ID-1997), which is a high priority outfall with high bacteria counts found in 2021 screenings. There are existing islands of vegetation between parking rows that may currently aid in reducing the rate of stormwater discharge. The Harbormaster also has plans to improve the site soon, therefore additional LID improvements could be implemented simultaneously.

Parking area slopes towards neighboring property along the fence, causing flooding.

The flooding on the neighboring property could be prevented with LID techniques. For example, a bioswale that can run down the entire length of the fence would capture the sheet flow of the parking area, filtering the runoff before entering the existing catch basins. The existing vegetated islands, which are acting as grass filter strips, may also be improved with additional bioswales or perhaps even interconnected tree pits that are also connected to the storm drain with an underdrain.

on the neighboring property and the stormwater that leaves the catch basin on site directly drains to a high priority outfall. A bioswale along the entire length of the fence at the bottom of the slope is recommended at a minimum to address the drainage issues.

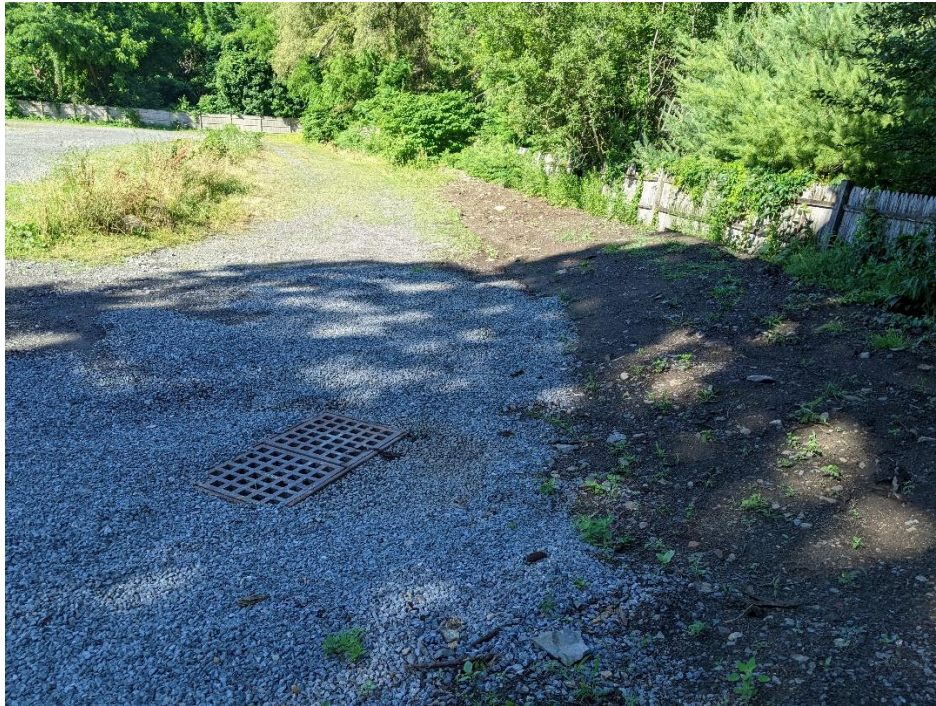
Existing double catch basin at the bottom of the sloped, gravel parking lot.

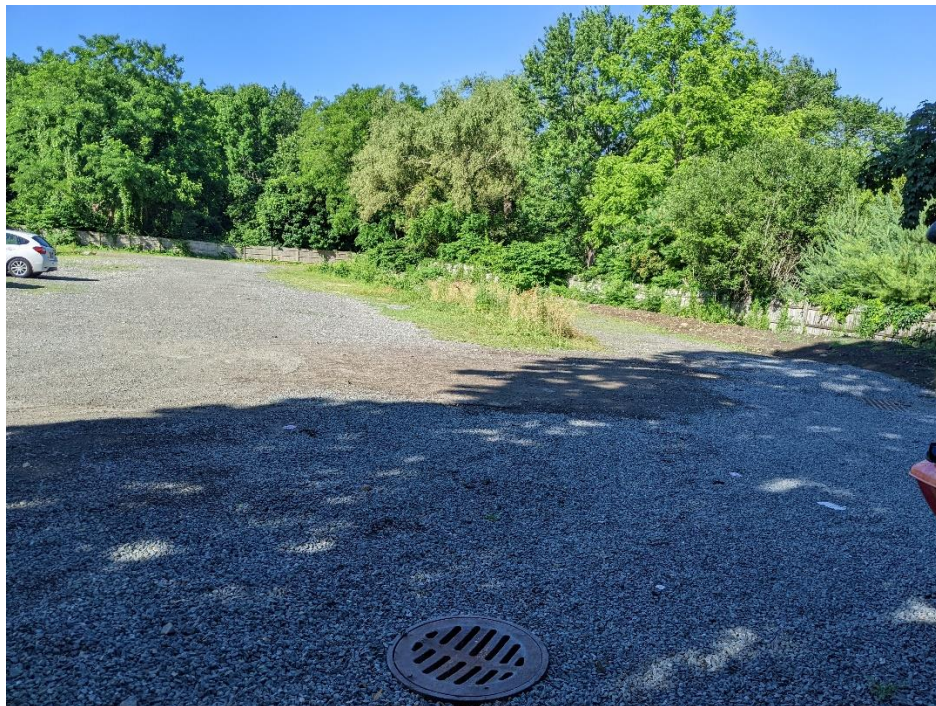
Another catch basin by the entrance of the parking lot. These drain to a nearby priority outfall.

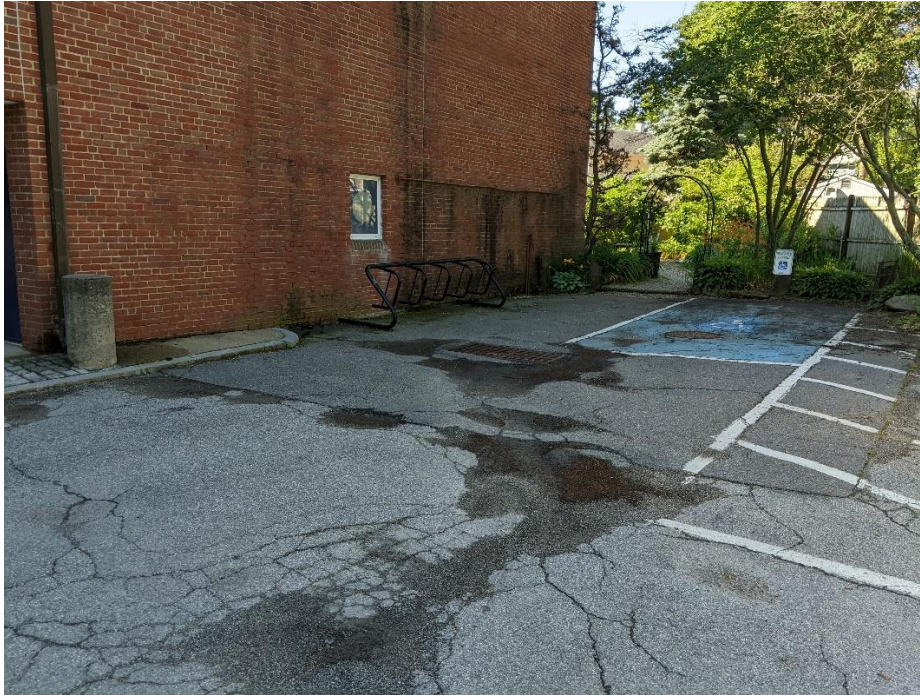
The paved parking area behind the Abbot Library slopes down from the street into a low-lying area. Signs of pooling stormwater are apparent by a double catch basin several feet away from the side of the brick

Water pools at the catch basins next to the library building. An elevated garden area at the far end of the lot could potentially be utilized for green infrastructure.

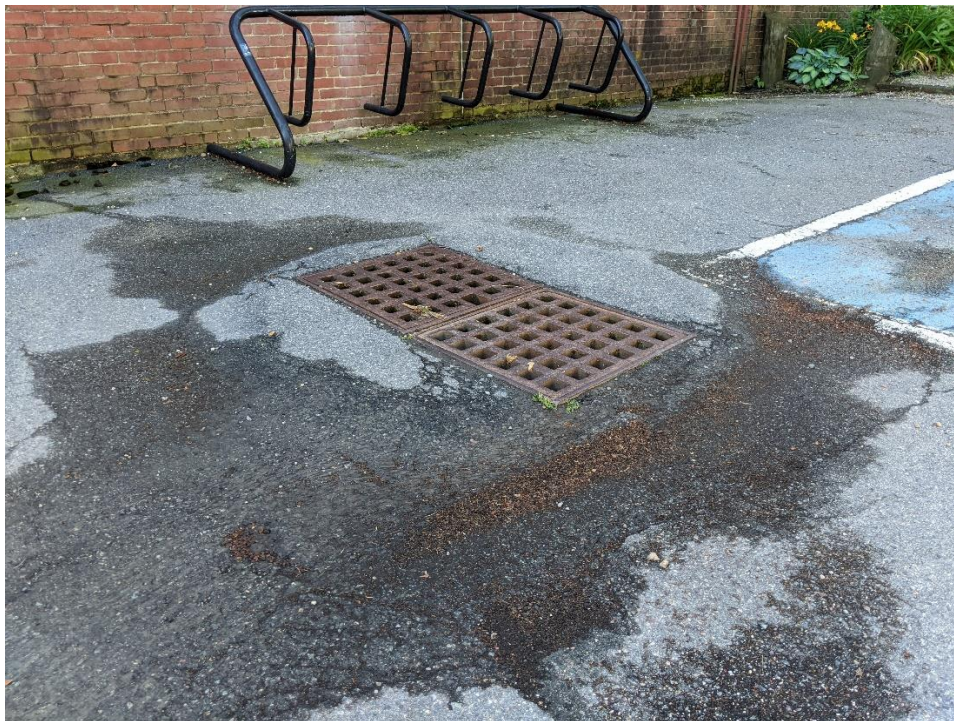
Complaints of flooding in this parking area make it a high priority for redevelopment.

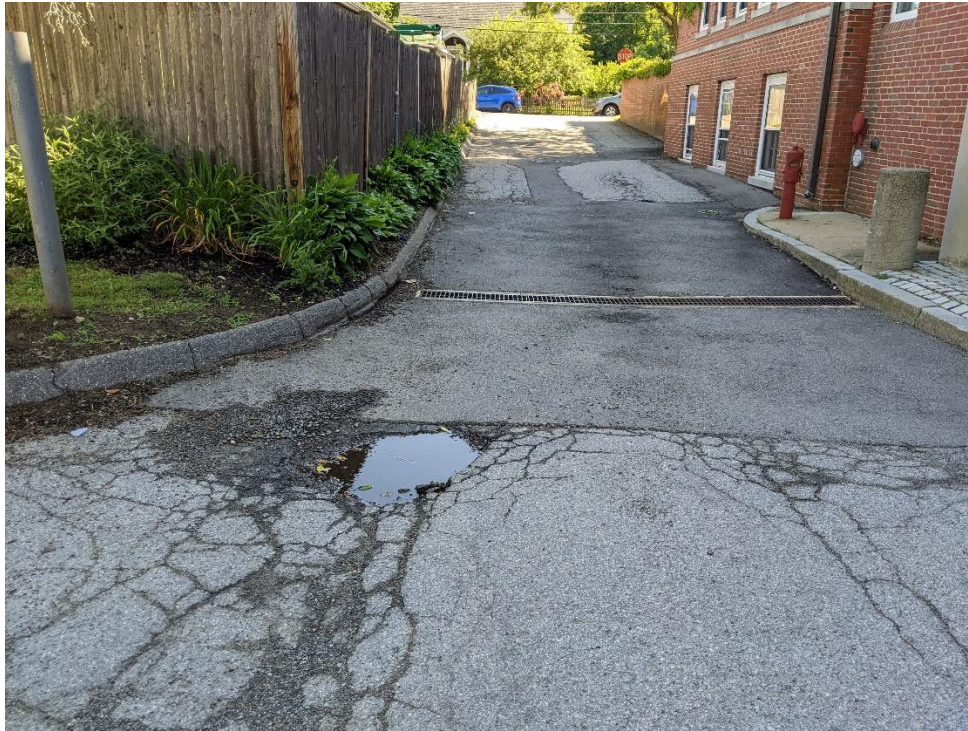
A long catch basin on the steep sloped driveway collects some runoff from the street. On the left, a vegetated island could be utilized for green infrastructure.

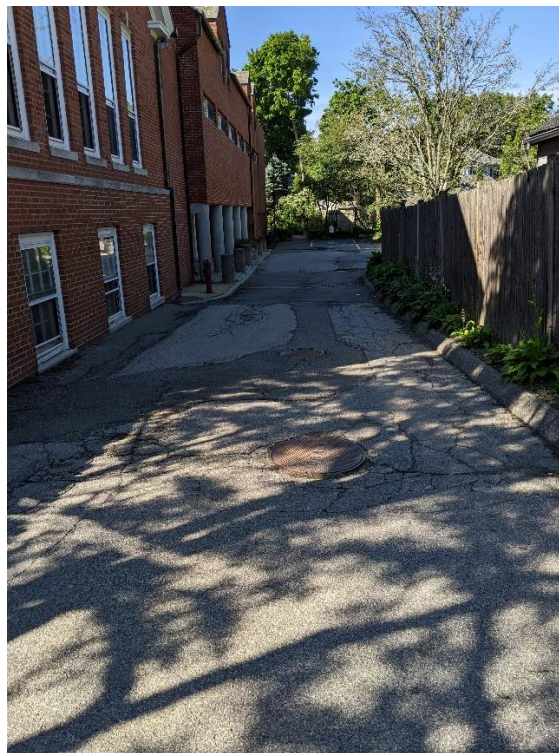
The building's gutter system discharges to the parking lot. Planter boxes could be placed along the edge of the building to collect and slow the discharge of roof runoff.

Compact LID techniques were considered for the library parking area since space is limited and it is closely abutting the building and neighboring properties. Planter boxes could be installed along the length of the building to temporarily store and filter the rainwater exiting the gutters that are contributing to the flooding. Permeable paving could be an option for slowing down and absorbing the water depending on the filtration characteristics of the soil on the site and the water table. The existing curb bump out as one enters the parking lot could be modified as a bioswale or tree box filter. The perimeter of the parking area, if space allows, could also be retrofitted with a bio swale to filter and slow the conveyance of water to the storm drain. The catch basins at the bottom of the driveway that collect most of the water could be modified into a rain garden with an overflow catch basin to slow the discharge rate. The rain garden could be an aesthetic addition to the existing garden and be an educational opportunity for visitors. However, the proximity to the building, soil characteristics, and water table must be factored into the final design.

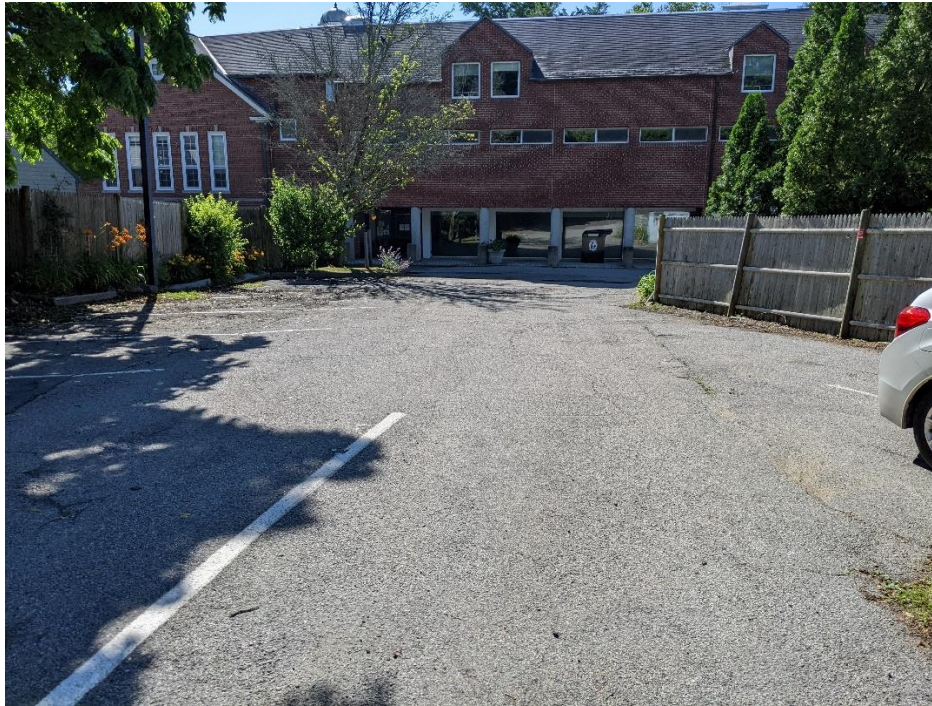
Neighboring properties are close to the edge of the parking area, and the slope of the parking areas goes towards the library building.

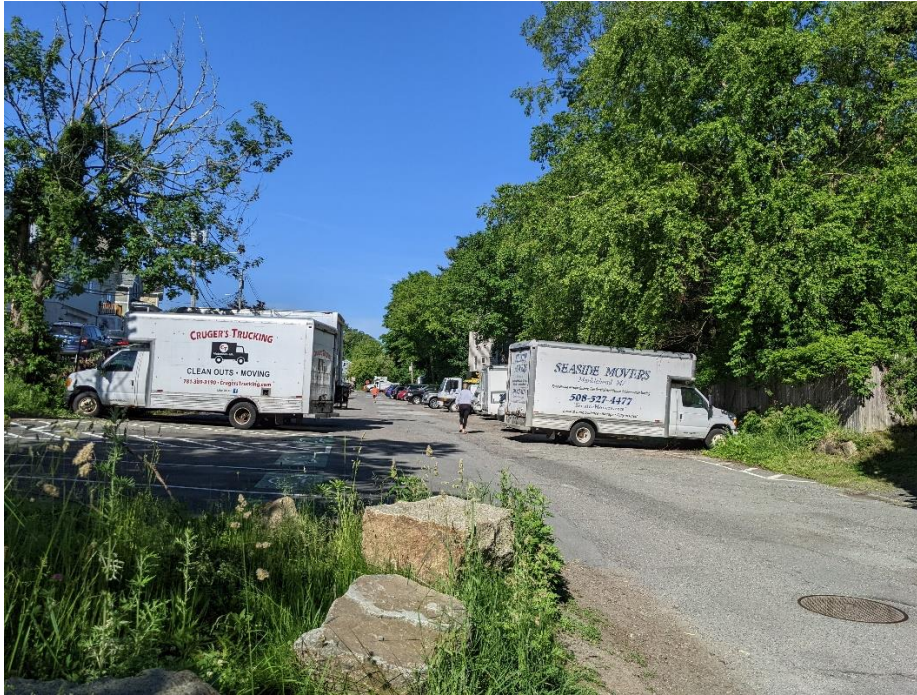
There are no catch basins or stormwater controls on this site. A vegetated island at the bottom of the parking lot could be utilized for green infrastructure.

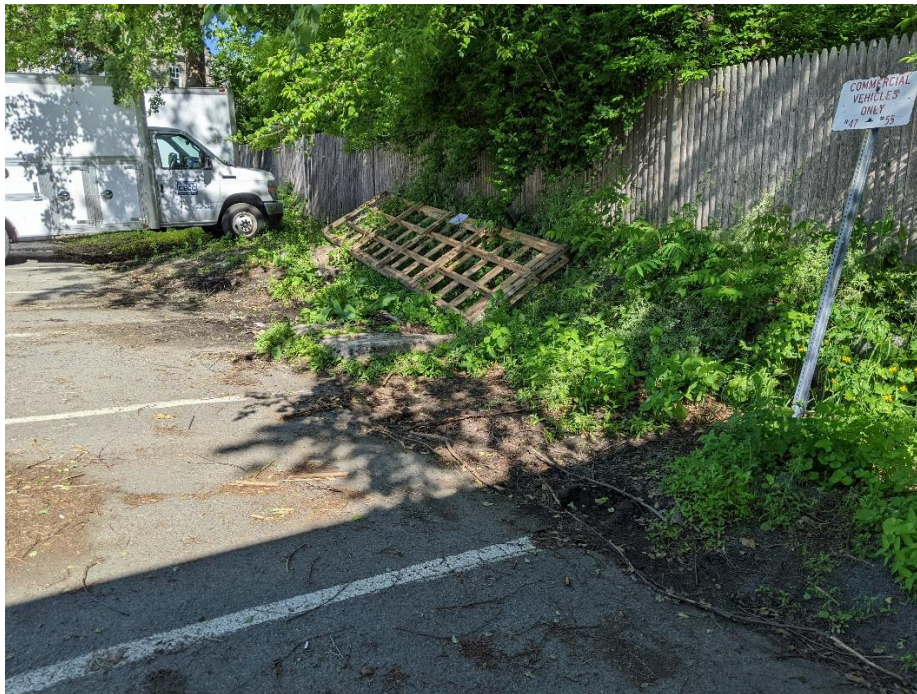
There is existing green space along the edge of the parking area that could be used for a bioswale.

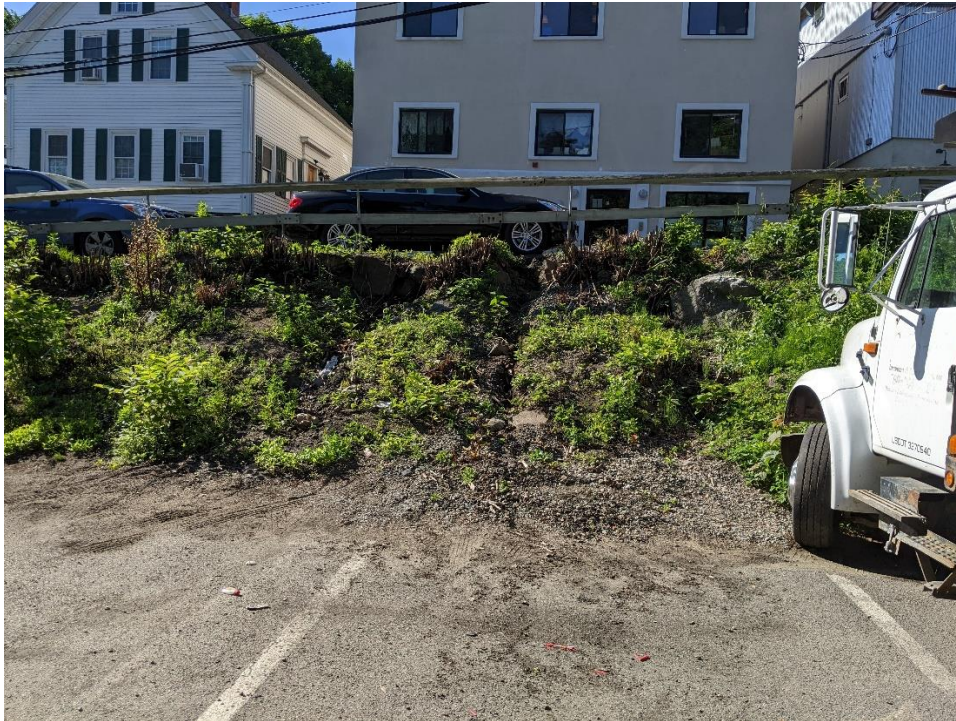
The parking area on Roundhouse Rd is a long, narrow, paved lot with two steep slopes of rock and vegetation coming down from the street and neighboring properties. These slopes have visible erosion, seen notably on the slope coming down from Anderson St. The parking lot is slightly sloped going down towards School Street with no catch basins despite the storm drain running down the length of the area. There are several drain manholes in the middle of the parking area. The lot is located within the Riverhead catchment area, which is ranked as high priority for improving the quality of stormwater. While there are no plans to make improvements on the site, there is a strong interest in this site for adding green stormwater infrastructure.

The steep slope along one edge is eroding.

Each side of the parking area currently acts as a vegetative buffer since it includes dense vegetation and trees. However, the steep slope must be additionally stabilized, or the stormwater diverted on Anderson Street to prevent erosion of this slope. Along the length of the sides of the parking lot could also have bio swales or tree pits. Vegetated islands with bio swales going perpendicular to the slope of the pavement could also slow the flow of water going down the length of the parking area. The drain manholes in the middle of the parking lot could also be retrofitted with hydrodynamic separators to help collect sediment, oil, and grease. The grassy area at the bottom of the slope that contains the granite blocks could be modified into a rain garden with an overflow catch basin. The addition of green infrastructure in this area could drastically improve the aesthetics and stormwater management of Roundhouse Road.

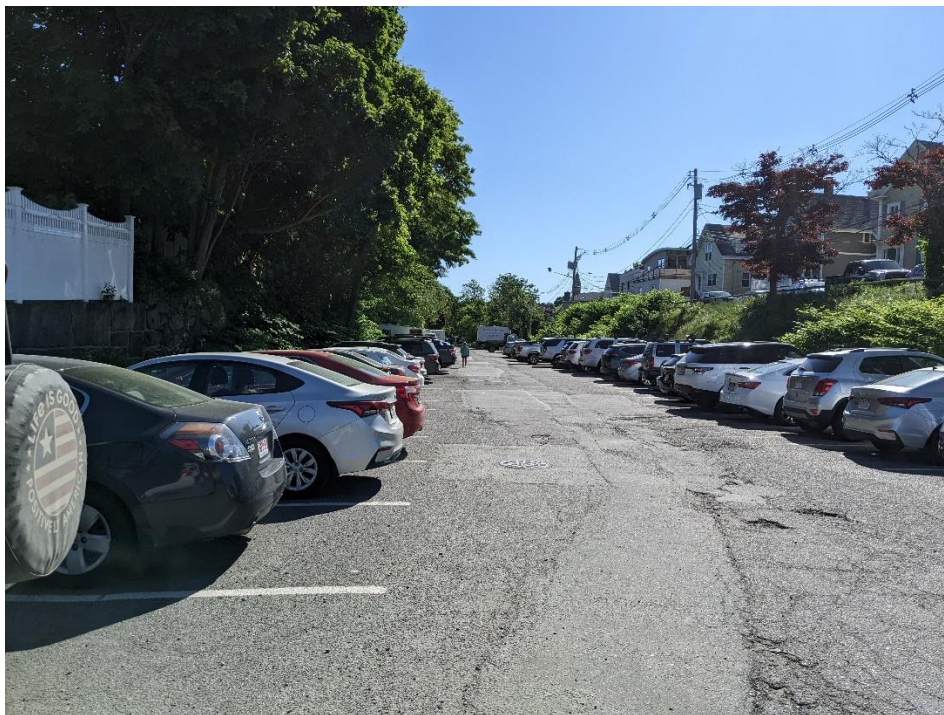
A drainpipe runs through the length of the parking lot, allowing for the opportunity to add stormwater infrastructure.

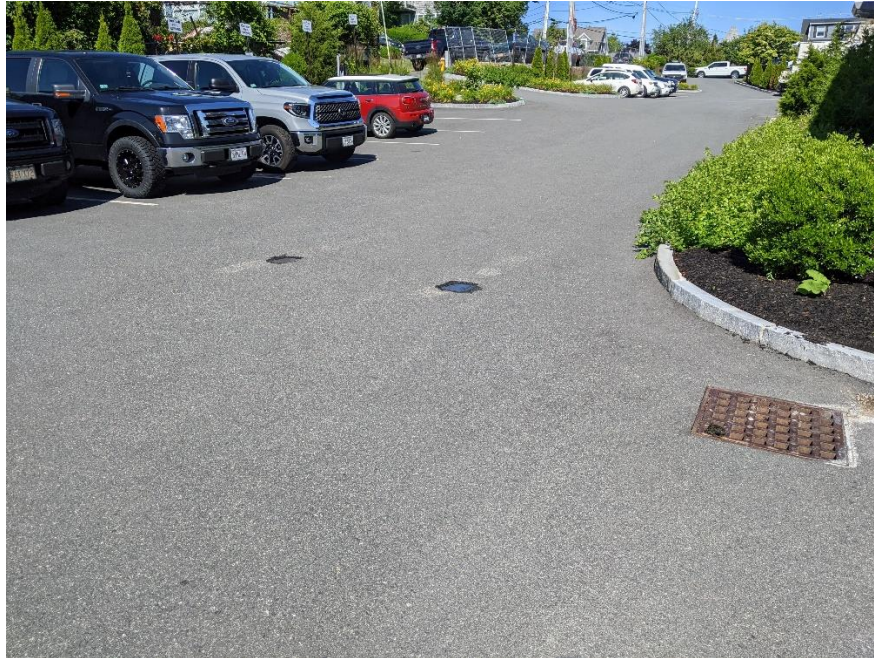
The parking area slopes down towards the harbor, with two catch basins on the paved section of the lot.

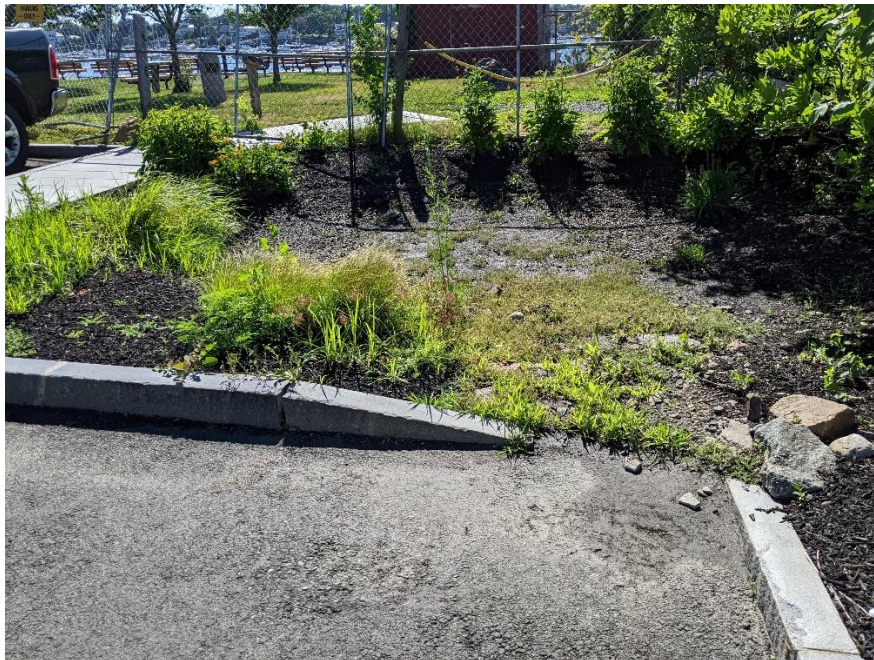
One of two bioretention areas that appears to not infiltrate due to signs of sediment setting on the pavement.

The two retention areas at the bottom of the sloping parking lot should be redesigned to better collect and contain stormwater. The depths of the beds are very shallow and may be dug deeper if it is appropriate for the site. The retention areas should also be planted with more dense vegetation to aid in absorbing and filtering the stormwater. The garden beds and curbed islands could be modified into bio swales with curb cuts or planter boxes that prevent washout of the mulch and soil. The catch basin at the

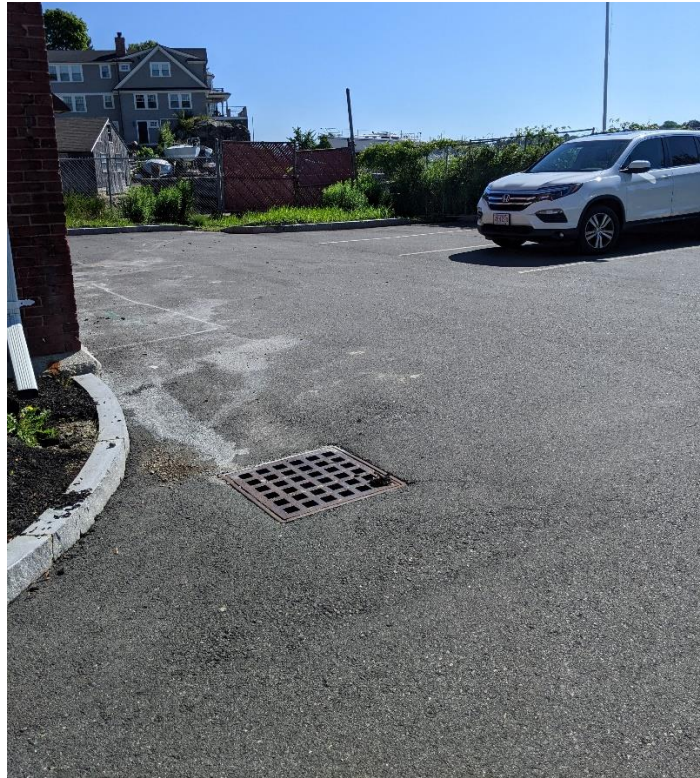
The building's gutter system discharges to the parking lot, causing erosion of the mulch in the garden bed. The bioretention area at the far end also seems to drain to the catch basin, causing discoloration of the pavement.

bottom of the parking lot on the corner of the building could also be retrofitted with a filtration insert, since there are signs of sediment on the pavement left by stormwater entering this catch basin.

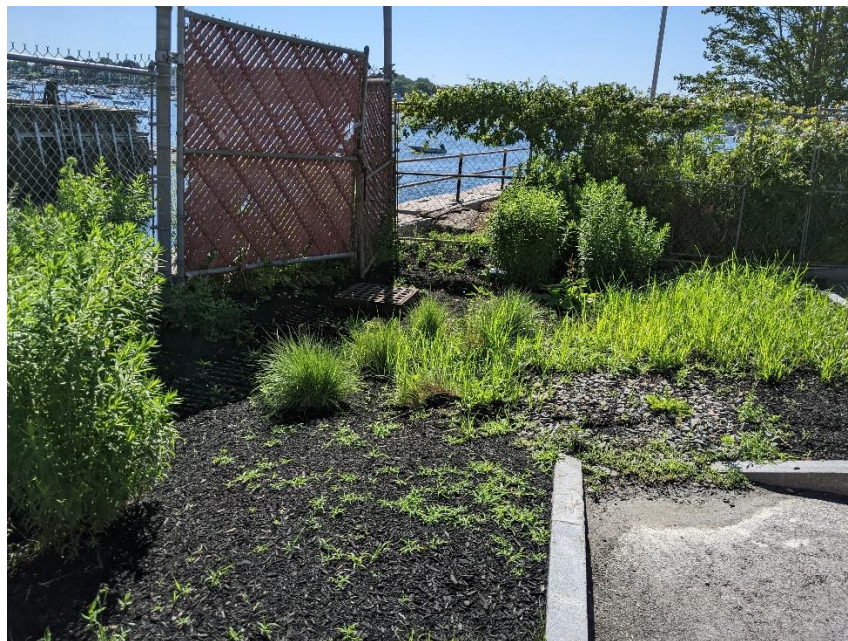
The second bioretention area does not seem to collect and infiltrate runoff effectively. An overflow catch basin also exists in this area.

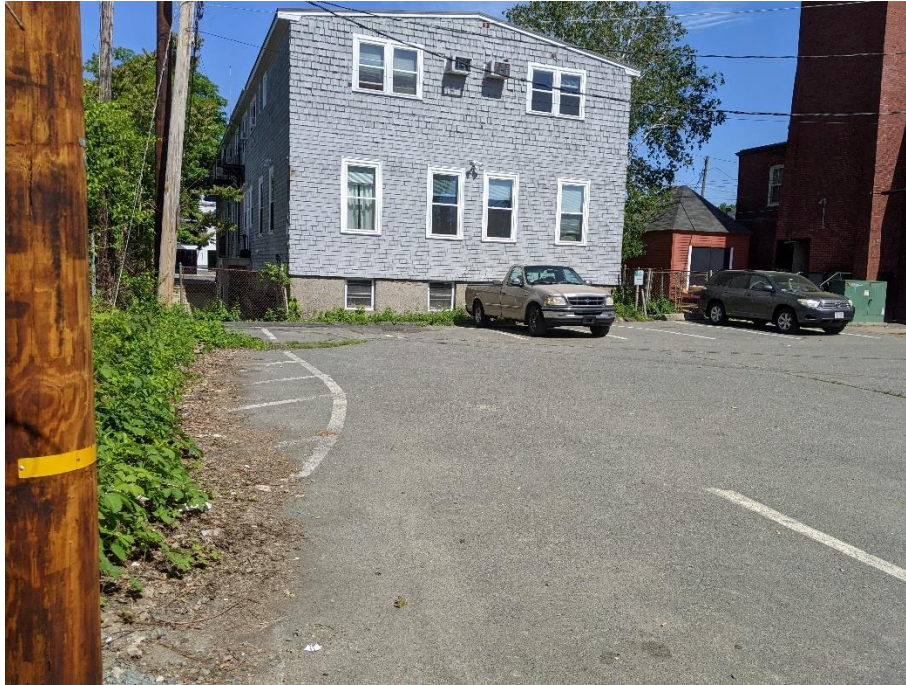
There is one catch basin in this parking area next to a neighboring building. There is another long catch in the driveway next to the main street.

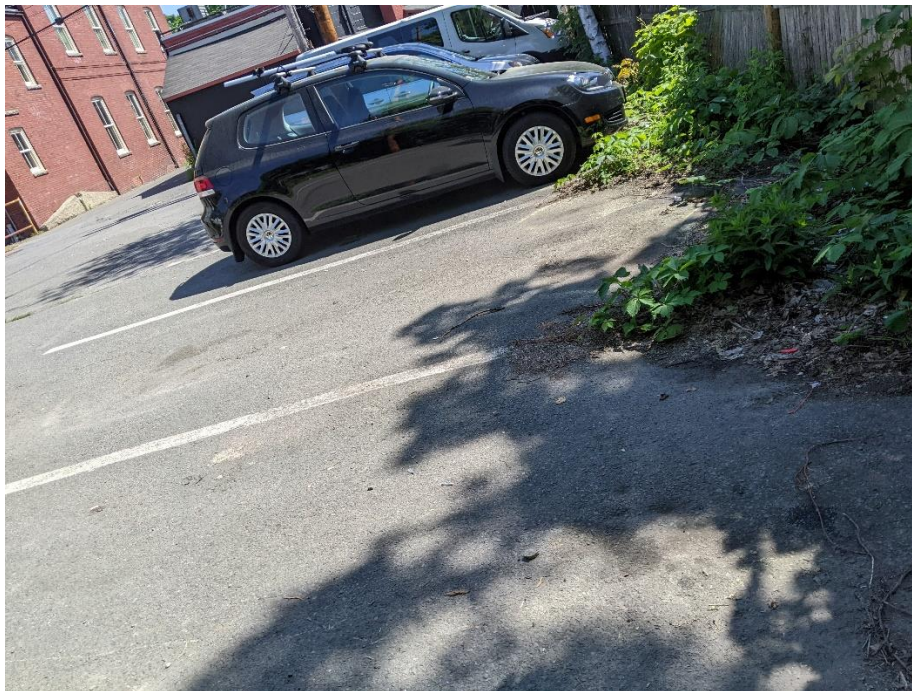
The parking area is small with some green space along the perimeter.

The parking lot behind School Street may be a good candidate for permeable paving, because it is small and low traffic. A bioswale or tree pit system could be constructed around the perimeter that leads to one of the catch basins on the site.
