# Abbot Hall Façade and Grounds Inspection & Assessment Report

Town of Marblehead, Massachusetts

June 30, 2017

# Abbot Hall - Exterior Envelope and Ground Assessment

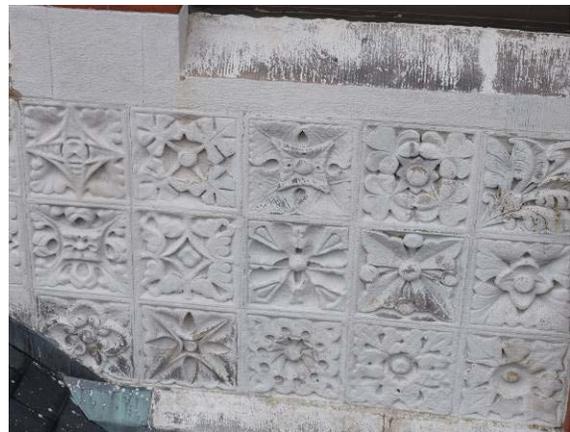
*Medallions*

Directly above the portico roof there are sculpted medallions. Each medallion is unique, and the majority of the medallions are in very good condition. The medallions have mortar joints between each stone that have failed, letting water in. The medallions have been coated with the white non-breathable coating that should be removed to preserve the sculpture.

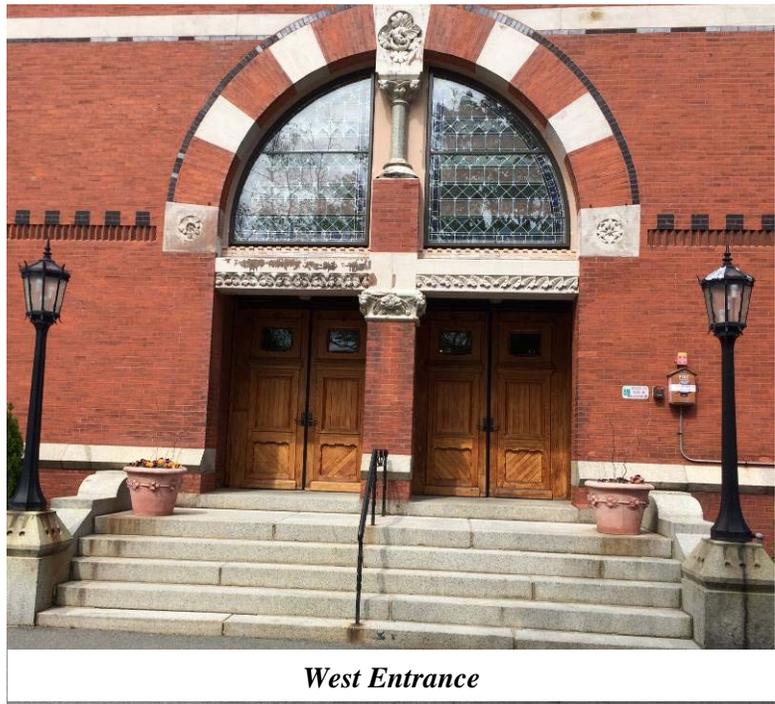
*West Entrance*

The carved header stones over the entrances are in very good condition. There is the white cementitious coating over all the sandstone that needs to be removed. The capital on the brick column has retained a lot of it's detail but has areas that are flaking and spalling at the underside on the carvings. The granite column between the stained glass is identified on the original drawings as the only granite column on the building. The carved sandstone capital on the granite column has retained most of the carved details but has minor spalling of the elements below the undercut carvings. The rosettes in the arch are in good condition with a high level of detail retention.

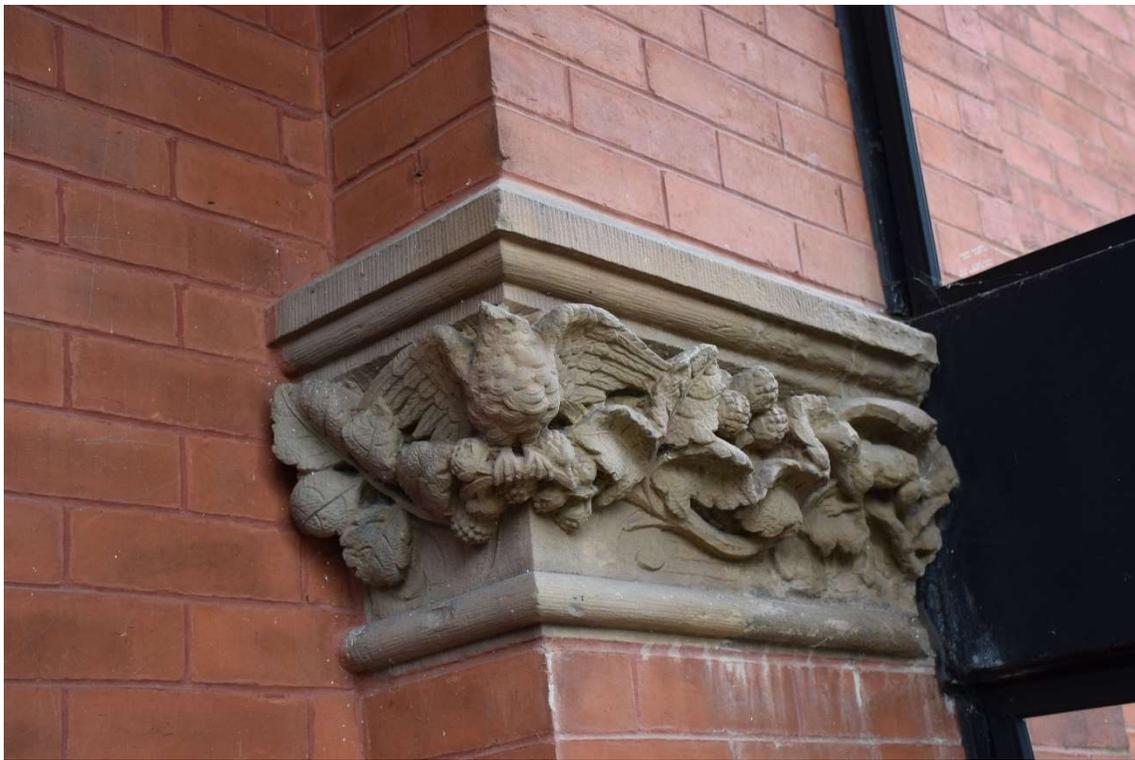
East Entry Portico Sculpture

The pinnacle of the gable is missing the original carved Nova Scotia Sandstone finial. At the east portico there are highly decorative bird and grape vine sculpted bands that wrap the pillars of the portico. In the 1970's glass doors and windows were installed to enclose the portico and the sculpture was cut for the installation of the glass. The condition of the sculpture varies significantly depending on the

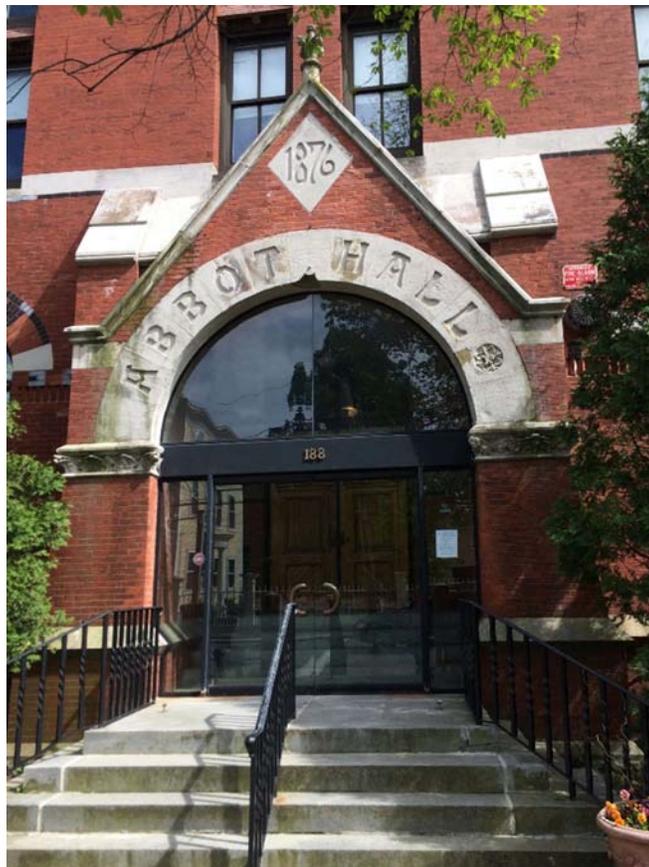
North Entry Portico

The north entrance to Abbot Hall, designed as the main entrance to the building is located directly off Washington Street, while the east and west entrances are entered from inside the grounds. The projecting portico and gable are entered through a half round opening with a decorative sandstone trim that bears the inscriptions “ABBOT HALL” and “1876”. All of the sandstone at the entrance has been coated with the cementitious coating and needs to be removed. At the peak of the half round opening a corroding ferrous pin caused a softball size piece of sandstone to fall out in the summer of 2016. There are two additional ferrous pins and all of them should be removed. Sloped sandstone shingle stones serve as the roof of the portico topped with a decorative carved finial. The carved finial has weathered but still has retained some of its detailing. The sculpted band stone has retained most of its carved detail and is in good condition. The plantings at the north entry have overgrown the portico and put the entrance in the shade for most of the day. There is biological grown and staining on the majority of the stone and brick at the entrance.

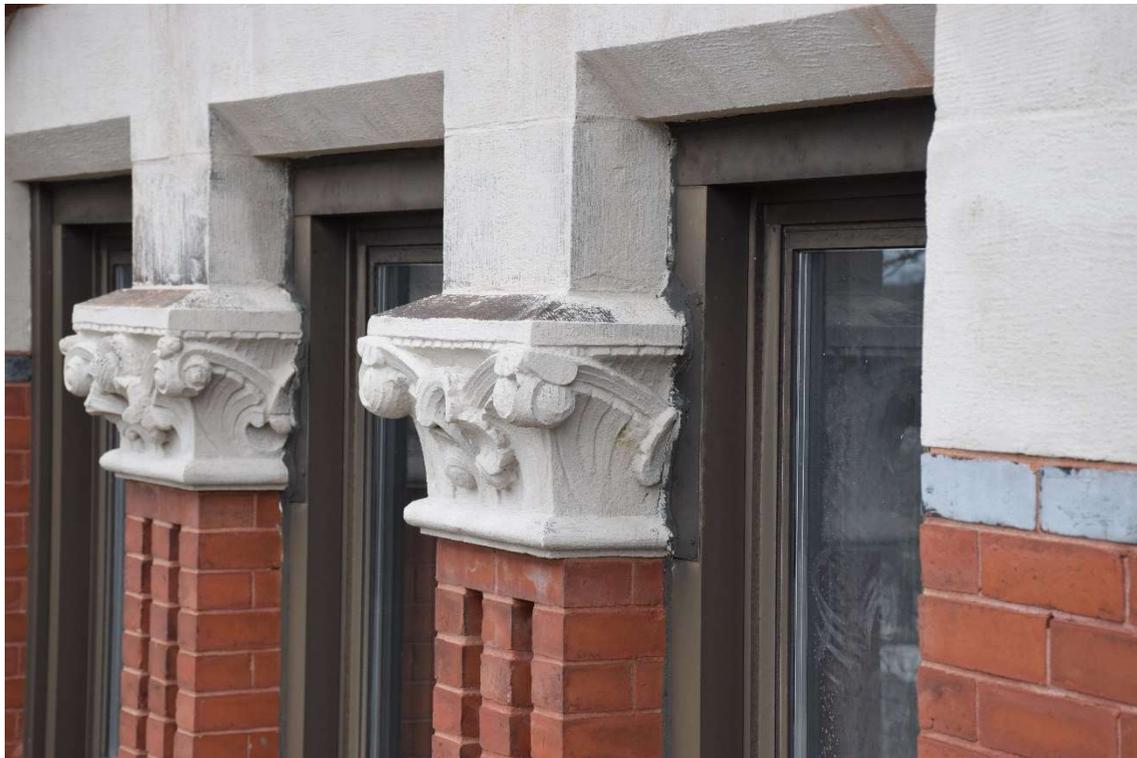
North Elevation Capitals

Between the windows above the portico are sculpted column capitals. The capitals sit on rectangular columns and support arched brick window openings. The north side capital is heavily weathered with very little detail remaining. The center capital has retained some detail but has significant weathering. The south side capital has retained most of its detail and is in good condition.

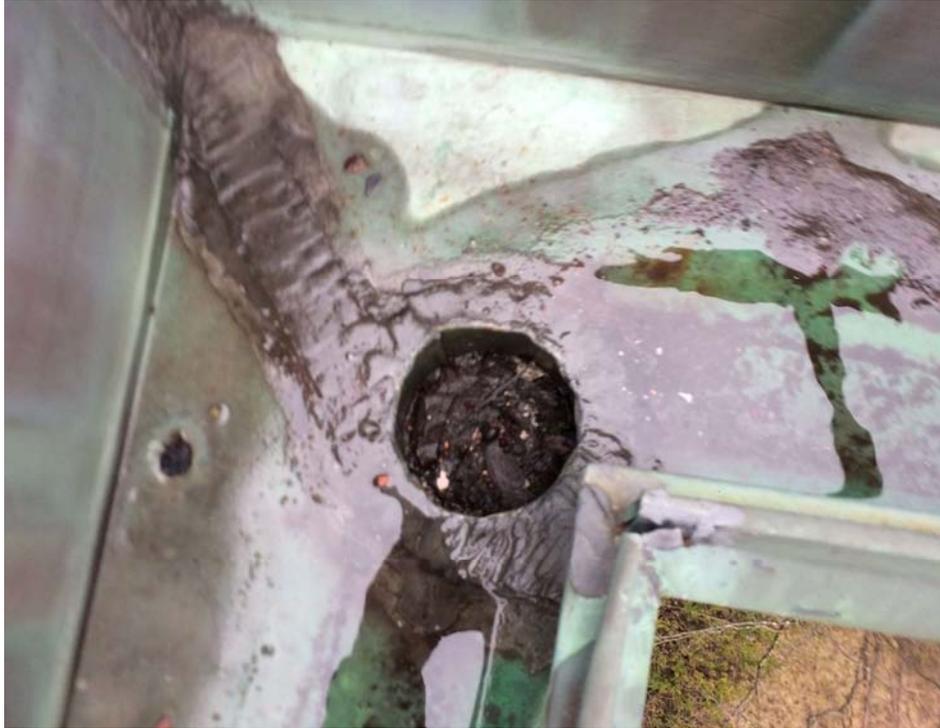
The gutters at Abbot Hall were replaced in the 1970's and are generally in good condition. The proper ¼" copper support bar, twisted hangers, 20 oz. copper, and full sheet profile was used for the installation. The downspout connection at the northeast corner is clogged and appears to have been clogged for a long time. In the center of the north main roof gutter there was a copper patch that was installed. This patch has failed and is allowing water to go through a failed joint. The current gutters are in good condition but the brick directly under them has significant deterioration. To replace the brick below the gutters it is likely that the gutters will have to be replaced as well.

Clogged Down Spout

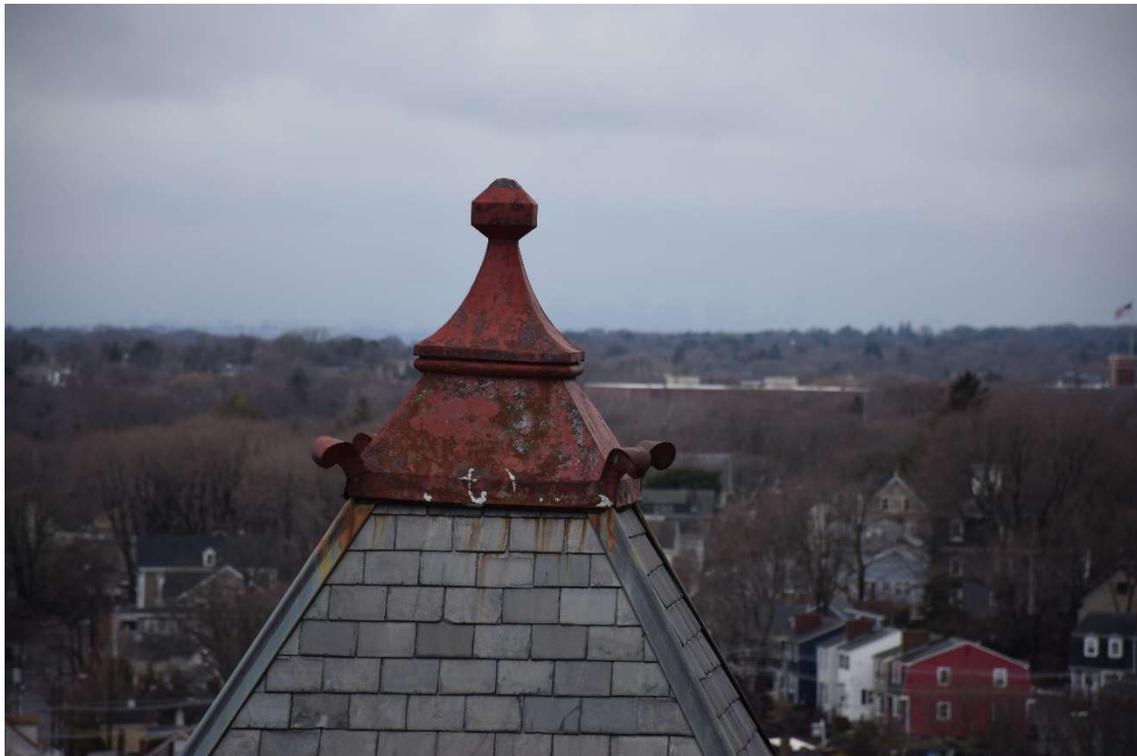
West Elevation Finial

The finials at Abbot Hall are galvanized iron. The galvanization has been failing for a period of time that has allowed the steel to rust. The majority of the finials have a layer of rust on them and have started to stain the adjacent materials. Originally there was steel cresting that adorned all peaks and ridges of Abbot Hall with a heavy galvanized iron ridge. The current iron finials all have patches at the top surface from when the cresting was removed. The iron ridges were removed and replaced with smaller copper ridges. On the portico of the east elevation the only remaining piece of cresting remains. Galvanization has vastly improved since the original galvanized iron was used on Abbot Hall. Replication cresting can be expected to have a much longer service life than the original cresting that was installed.

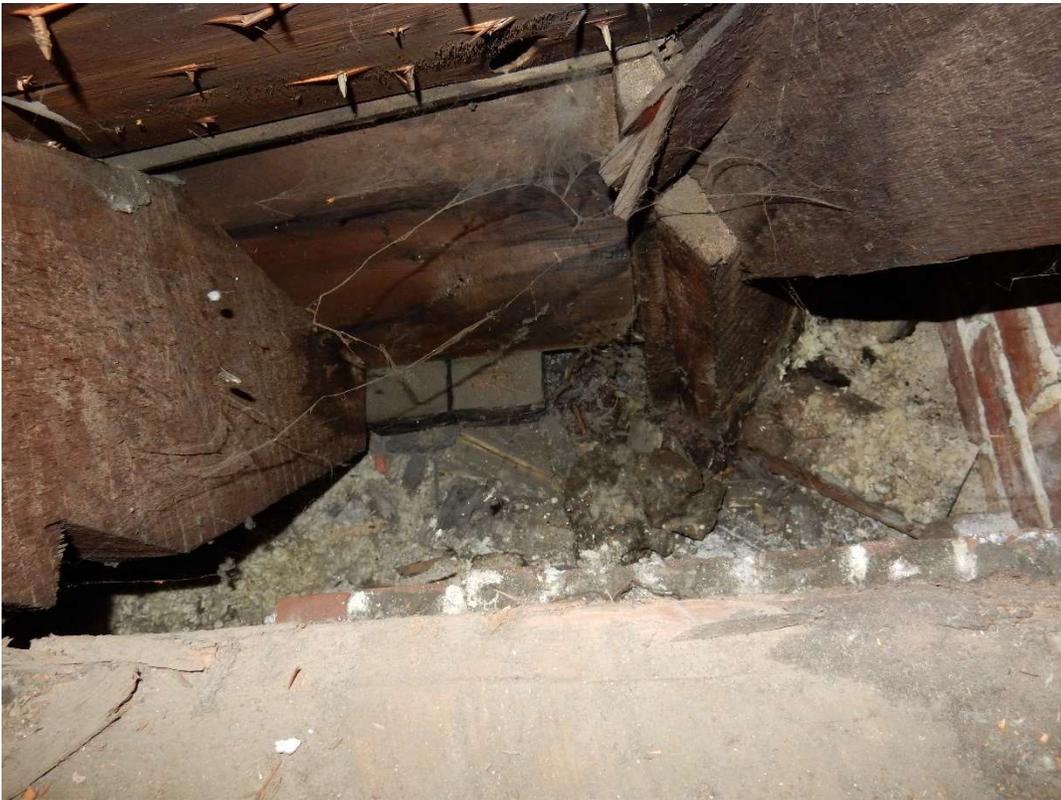
Backside of Gutter and Brick Below

There is a header course of black glazed brick directly below the gutter that supports the gutter. This course of brick is in very poor condition and is not tied into the Nova Scotia Sandstone band below. The brick has no masonry behind it and overhangs the brick cornice below up to 2 ¼". All of the mortar is deteriorated and all of the bricks are loose. At all outside corners the header course is cantilevered at both the head and long face of the brick. At this location the brick is cantilevered 2 ¼" out with a thickness of 3 5/8". These bricks are only held in place by the friction of the gutter above. To repair and stabilize this course of brick the

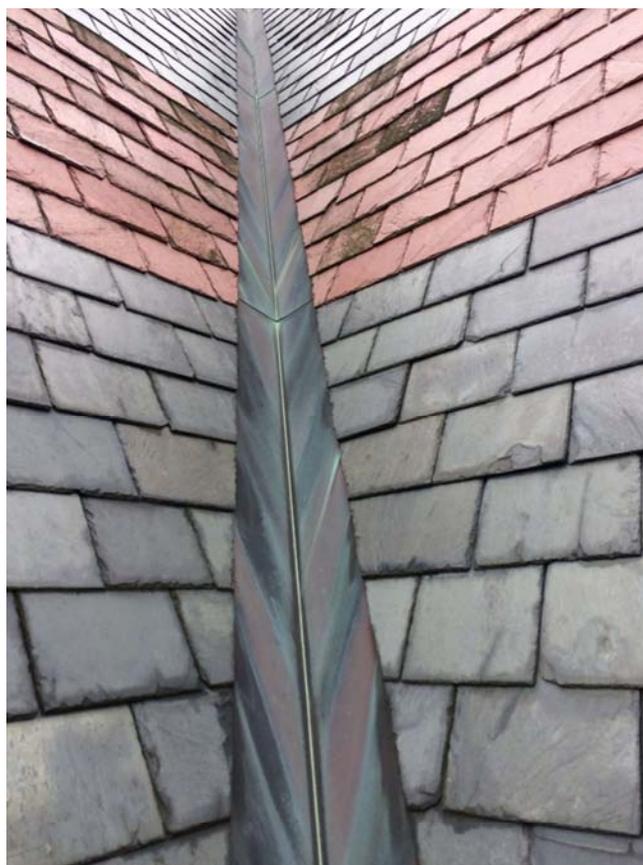
roof was installed in the 1970's with the combination of salvaged slate from offsite, and reclaimed slate from the roof. The original slate was almost certainly Black Monson State quarried in Monson, Maine. This northern Maine slate was both very popular in New England when Abbot Hall was constructed and is considered to be the most durable slate ever produced. Although Black Monson is no longer available for roofing slate, a very similar black slate (North Country Black) is quarried just across the Canadian border. The red slate is still actively quarried out of two quarries that both align on the New York Vermont border. The slate on the steeply sloped roof are in fair condition. There are limited number of broken and cracked slate that should be repaired. At the top of Abbot Hall is a lower sloped slate roof. At this location the slate are in much worse condition. There is a large number of broken and missing slate, with many additional cracked slate. In the 1970's new copper valley's, skirt, and flashings were installed. The stepper valley are in serviceable condition with limited signs of wear. At the low sloped skirt that creates the transition from the low sloped roof to the steep sloped roof there are many pin holes and fastening separations. An iron snow rail was installed on the skirt and is causing the solders and attachments to open. The low sloping valleys at the edges of the low sloped roof also have signs of significant weathering and should be replaced.

Typical Valley

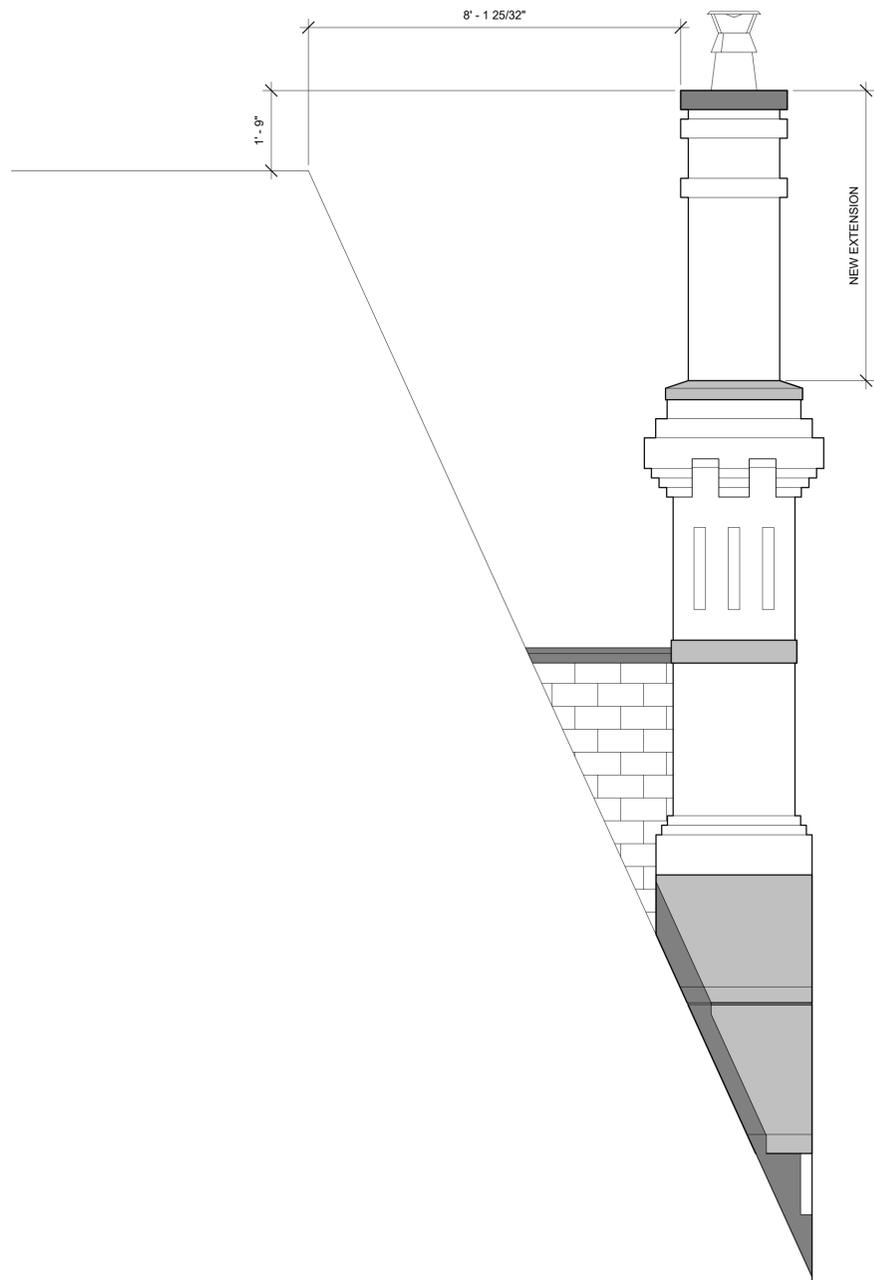
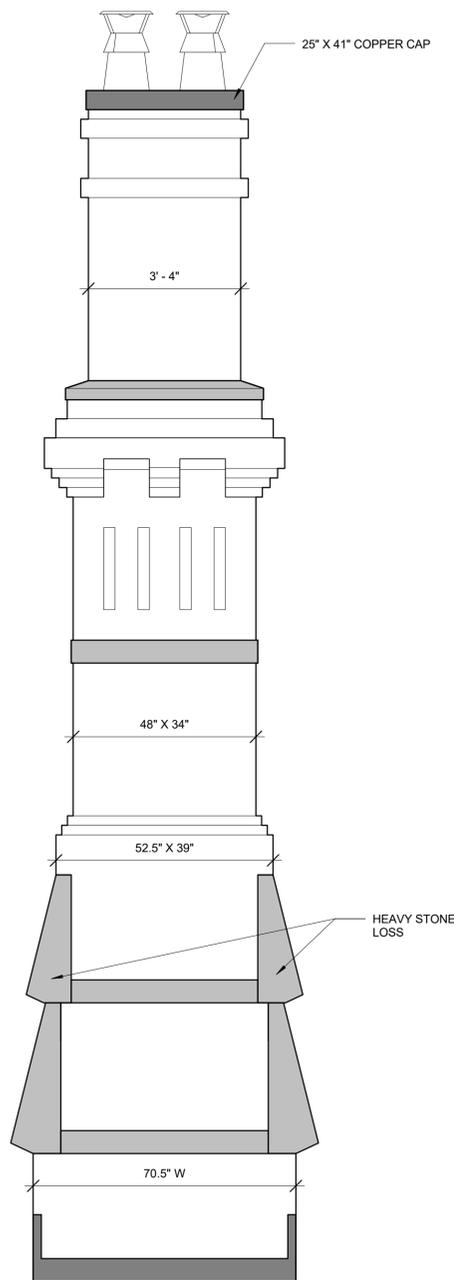
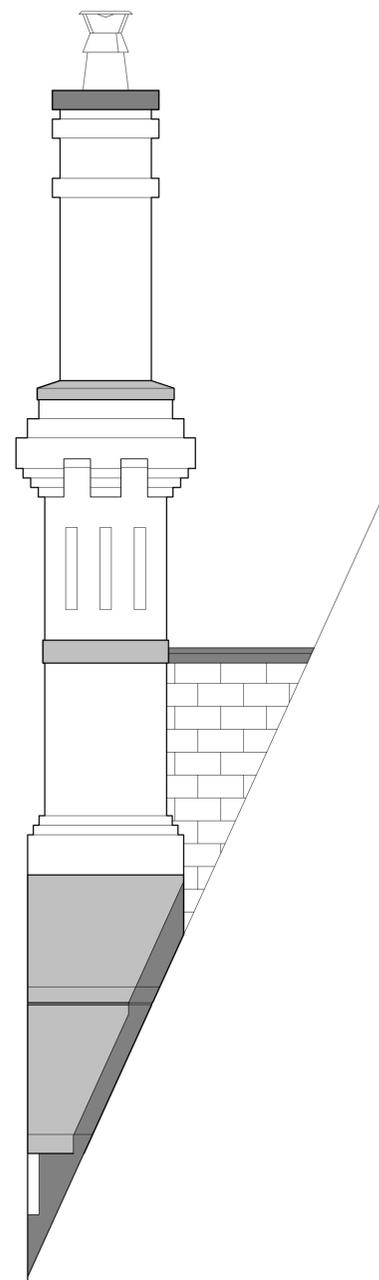
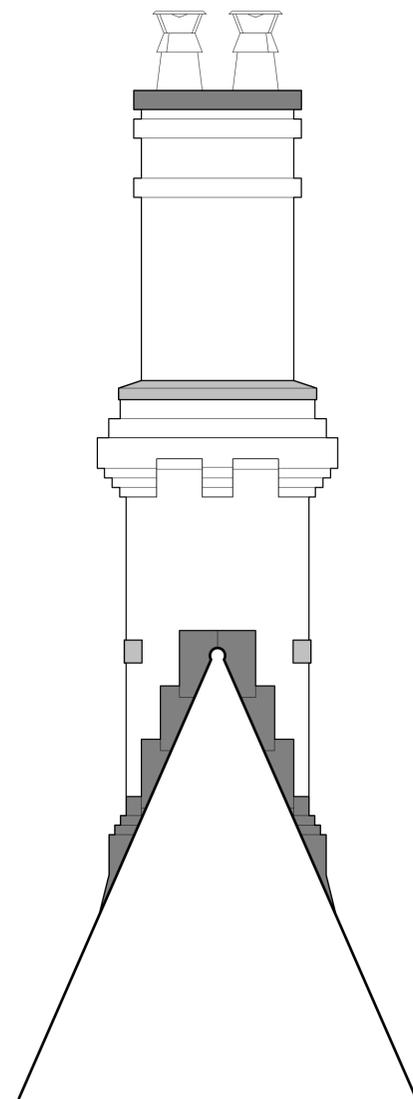
**1 Chimney West Elevation**  
1/2" = 1'-0"

- The chimney on the south elevation is in very poor condition. All mortar joints have failed. An extension was built on top of the original chimney and is in very poor condition as well. The brick are in loose and unstable condition.
